Access Compliance Report Public Rights-of-Way (Curb Ramps)

Intersection ID: 48774 Main Street: TURNING_WHEEL_DR Cross Street: OLD_FORESTER_LN Location: SW

ADA ID: FFF2E81A8517 Ramp Type: BlendTrans1 Initial Pass/Fail: Fail Overall Compliance: No Severity Score: 21.25

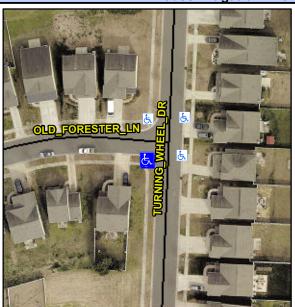
Compl	liance Description	Data	Comp	liance	Description	Data
N/A	Ramp Length (in)	72.0	Yes	Blend	Trans Slope (%)	3.2
No	Ramp Width (in)	46.0	No	Blend	lTrans XSlope (%)	5.2
N/A	Flare Type LT	N/A	N/A	Flare	Type RT	N/A
N/A	Flare Slope LT (%)	N/A	N/A	Flare	Slope RT (%)	N/A
N/A	Flare Traversable LT?	N/A	N/A	Flare	Traversable RT?	N/A
N/A	Landing Length (in)	N/A	N/A	DWS	Provided?	N/A
N/A	Landing Width (in)	N/A	N/A	DWS	Contrast?	N/A
N/A	Landing Slope (%)	N/A	N/A	DWS	Length (in)	N/A
N/A	Landing X Slope (%)	N/A	N/A	DWS	Full Width?	N/A
N/A	Landing Curb? (Y/N)	N/A	N/A	DWS	Offset (in)	N/A
N/A	Shared Landing?	N/A				
N/A	Gutter Ponding?	N/A	N/A	Gutte	er Slope (%)	N/A
N/A	Gutter Lip Ht (in)	N/A	N/A	Gutte	er X Slope (%)	N/A
N/A	Painted X Walk1?	No	N/A	Paint	ed X Walk2?	No
	X Walk 1 Direction	To E		X Wa	lk 2 Direction	To N
	X Walk 1 Width (in)	N/A		X Wa	lk 2 Width (in)	N/A
	X Walk 1 Slope (%)	3.4		X Wa	lk 2 Slope (%)	0.2
	X Walk 1 X Slope (%)	2.2		X Wa	lk 2 X Slope (%)	4.2

N/A	Ramp inside XWalk1?	N/A	N/A	Ram	o inside XWalk2?	N/A
	Road Slope (%)	4.3		Clear	Space?	N/A
	Road X Slope (%)	2.5	N/A	Clear	Space to XWalk (in)	N/A
N/A	Any Obstructions?	N/A	N/A	Storn	n Grate/Utility Hazard?	N/A
	Obstruction Type			Storn	n Grate/Utility Type	
		N/A				N/A
			Yes	Surfa	ce Condition? (G/P)	Good
			N/A	Curb	Slope (%)	4.8

Remove & Replace Curb Ramp With Two New Directional Ramps or Equivalent.

R304.5.1, R304.5.3
