Access Compliance Report

Public Rights-of-Way

(Curb Ramps)

Intersection ID: 48953	Main Street: DAVID_JENNINGS_AV	Cross Street: GATESMILLS_AV	Location: NE
ADA ID: FFF65FB87980	Ramp Type: Perp	Initial Pass/Fail: Fail	Overall Compliance: No
Severity Score: 10			
Codes/Mitigation Info/Possible Solution		Field Measurements/Component Compliance

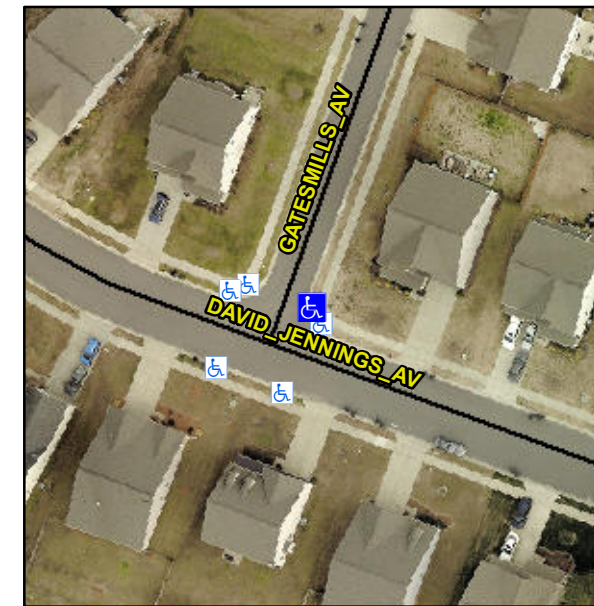
Not Found, R304.5.1, R304.5.3

Compliance	Description	Data	Compliance	Description	Data
N/A	Ramp Length (in)	44.5	Yes	Ramp Slope (%)	5.8
No	Ramp Width (in)	47.5	No	Ramp XSlope (%)	2.2
N/A	Flare Type LT	N/A	N/A	Flare Type RT	N/A
N/A	Flare Slope LT (%)	N/A	N/A	Flare Slope RT (%)	N/A
N/A	Flare Traversable LT?	N/A	N/A	Flare Traversable RT?	N/A
N/A	Landing Length (in)	N/A	N/A	DWS Provided?	N/A
N/A	Landing Width (in)	N/A	N/A	DWS Contrast?	N/A
N/A	Landing Slope (%)	N/A	N/A	DWS Length (in)	N/A
N/A	Landing X Slope (%)	N/A	N/A	DWS Full Width?	N/A
N/A	Landing Curb? (Y/N)	N/A	N/A	DWS Offset (in)	N/A
N/A	Shared Landing?	N/A			
N/A	Gutter Ponding?	N/A	N/A	Gutter Slope (%)	N/A
N/A	Gutter Lip Ht (in)	N/A	N/A	Gutter X Slope (%)	N/A
N/A	Painted X Walk1?	No	N/A	Painted X Walk2?	N/A
	X Walk 1 Direction	To NW		X Walk 2 Direction	N/A
N/A	X Walk 1 Width (in)	N/A	N/A	X Walk 2 Width (in)	N/A
	X Walk 1 Slope (%)	0.9		X Walk 2 Slope (%)	N/A
	X Walk 1 X Slope (%)	4.4		X Walk 2 X Slope (%)	N/A

N/A	Ramp inside XWalk1?	N/A	N/A	Ramp inside XWalk2?	N/A
	Road Slope (%)	N/A	N/A	Clear Space?	N/A
	Road X Slope (%)	N/A	N/A	Clear Space to XWalk (in)	N/A
N/A	Any Obstructions?	N/A	N/A	Storm Grate/Utility Hazard?	N/A
	Obstruction Type			Storm Grate/Utility Type	
		N/A			N/A
		Yes		Surface Condition? (G/P)	Good

Remove & Replace Entire Ramp.

Total Cost: \$ 1850.00
