# Access Compliance Report

## Public Rights-of-Way

### (Curb Ramps)

Intersection ID: 28496	Main Street: AVIARY_HILL_WY	Cross Street: NORTHWOODS_FOREST_DR	Location: W
ADA ID: FFF8EBEA6CD8	Ramp Type: Perp	Initial Pass/Fail: Fail	Overall Compliance: No
Severity Score: 17.5			
Codes/Mitigation Info/Possible Solution		Field Measurements/Component Compliance

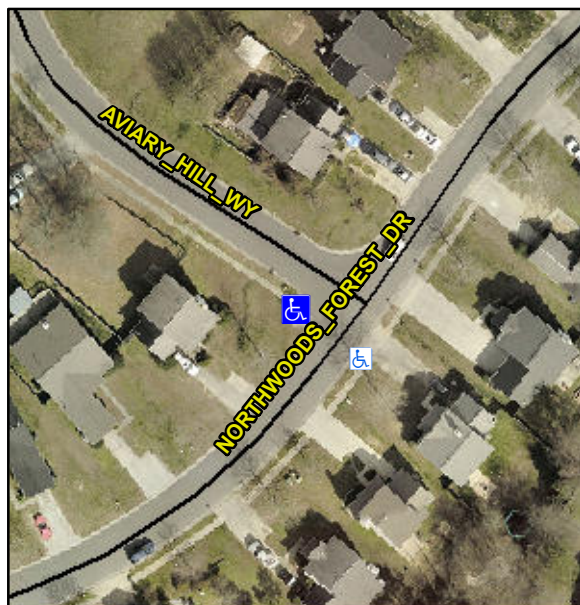
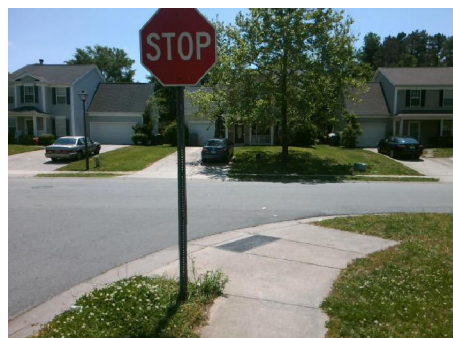
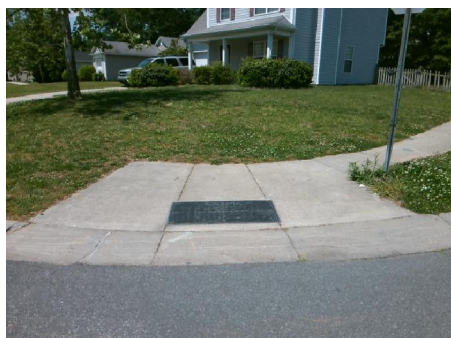
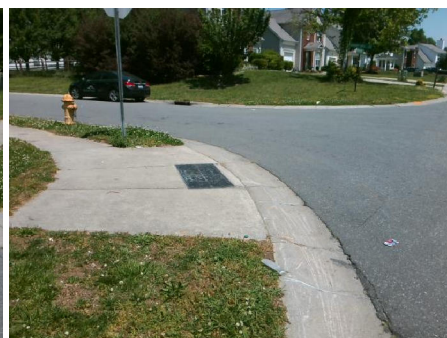
**Not Found, R304.5.1**

Compliance	Description	Data	Compliance	Description	Data
N/A	Ramp Length (in)	94.0	Yes	Ramp Slope (%)	7.2
No	Ramp Width (in)	33.0	Yes	Ramp XSlope (%)	1.5
N/A	Flare Type LT	N/A	N/A	Flare Type RT	N/A
N/A	Flare Slope LT (%)	N/A	N/A	Flare Slope RT (%)	N/A
N/A	Flare Traversable LT?	N/A	N/A	Flare Traversable RT?	N/A
N/A	Landing Length (in)	N/A	N/A	DWS Provided?	N/A
N/A	Landing Width (in)	N/A	N/A	DWS Contrast?	N/A
N/A	Landing Slope (%)	N/A	N/A	DWS Length (in)	N/A
N/A	Landing X Slope (%)	N/A	N/A	DWS Full Width?	N/A
N/A	Landing Curb? (Y/N)	N/A	N/A	DWS Offset (in)	N/A
N/A	Shared Landing?	N/A			
N/A	Gutter Ponding?	N/A	N/A	Gutter Slope (%)	N/A
N/A	Gutter Lip Ht (in)	N/A	N/A	Gutter X Slope (%)	N/A
N/A	Painted X Walk1?	No	N/A	Painted X Walk2?	N/A
	X Walk 1 Direction	To SE		X Walk 2 Direction	N/A
N/A	X Walk 1 Width (in)	N/A	N/A	X Walk 2 Width (in)	N/A
	X Walk 1 Slope (%)	1.8		X Walk 2 Slope (%)	N/A
	X Walk 1 X Slope (%)	1.8		X Walk 2 X Slope (%)	N/A

N/A	Ramp inside XWalk1?	N/A	N/A	Ramp inside XWalk2?	N/A
	Road Slope (%)	N/A	N/A	Clear Space?	N/A
	Road X Slope (%)	N/A	N/A	Clear Space to XWalk (in)	N/A
N/A	Any Obstructions?	N/A	N/A	Storm Grate/Utility Hazard?	N/A
	Obstruction Type			Storm Grate/Utility Type	
		N/A			N/A
			Yes	Surface Condition? (G/P)	Good

**Remove & Replace Entire Ramp.**

Total Cost: \$ 1850.00
