N/A

Intersection ID: N/A **Main Street:** Cross Street: N/A Location: N/A

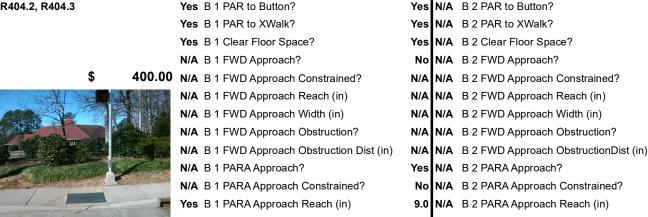
4			,	
				N/A B 1 PARA Approach Width (in)	N/A N	N/A	B 2 PARA Approach Width (in)	N/A
				N/A B 1 PARA Approach Obstruction?	? Yes N	N/A	B 2 PARA Approach Obstruction?	N/A
APS Compliance				N/A B 1 PARA Approach Obstruction	Dist (in) 3.0 N	N/A	B 2 PARA Approach ObstructionDist (in)	) <b>N/A</b>
Is Button 1 APS or Non-APS?	NonAPS	Is Button 2 APS or Non-APS?	N/A	No B 1 Clear Floor Space Slope (%)	) 4.2 N	N/A	B 2 Clear Floor Space Slope (%)	N/A
N/A B 1 VibroTact Arrow?	N/A N/	A B 2 VibroTact Arrow?	N/A	No B 1 Clear Floor Space XSlope (%	%) 7.9 N	N/A	B 2 Clear Floor Space XSlope (%)	N/A
N/A B 1 VibroTact Parallel to Xing?	<b>N/A N</b> //	A B 2 VibroTact Parallel to Xing?	N/A	N/A B 1 PAR Slope (%)	4.1 N	N/A	B 2 PAR Slope (%)	N/A
N/A B 1 VibroTact Contrast	<b>N/A N</b> //	A B 2 VibroTact Contrast	N/A	Yes B 1 Height (in)	42.0 N	N/A	B 2 Height (in)	N/A
N/A B 1 Pilot Light?	<b>N/A N</b> //	A B 2 Pilot Light?	N/A	Yes B 1 Pressure (#)	2.0 N	N/A	B 2 Pressure (#)	N/A

N/A B 1 Pilot Light Illumination?	N/A N/	A B 2 Pilot Light Illumination?	N/A	Yes B 1 Closed Fist Operation?	Yes	N/A	B 2 Closed Fist Operation?	N/A
N/A B 1 Verbal Walk Cycle?	N/A N/	A B 2 Verbal Walk Cycle?	N/A	MUTCD Compliance				
N/A B 1 Verbal Message Audible?	N/A N/	A B 2 Verbal Message Audible?	N/A	Yes B 1 Clear Xing Direction?	ClearlyMarked N	N/A	B 2 Clear Xing Direction?	N/A
N/A B 1 Locator Tone?	N/A N/	A B 2 Locator Tone?	N/A	B 1 Crossing Direction	To SE		B 2 Crossing Direction	N/A
N/A B 1 Percussive Walk Cycle?	N/A N/	A B 2 Percussive Walk Cycle?	N/A	Yes B 1 DistanceTo XWalk (in)	۱ 0.0	N/A	B 2 DistanceTo XWalk (in)	N/A

Possible Solutions: Remove and Replace Clear Space.

PROW/ADA: R404.2, R404.3
