Access Compliance Report Public Rights-of-Way (Pedestrian Signals)

Signal Type: One Push Button-Non APS Severity Score: BTN 1:N/A BTN 2: N/A No BTN: N/A ADA ID: 22C4F36E06DB **Overall Compliance: No**

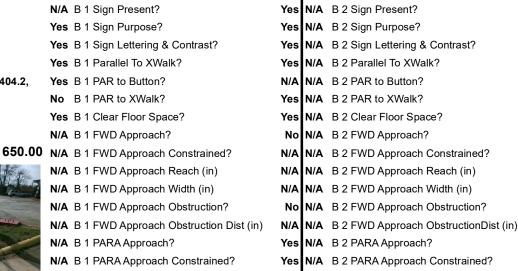
N/A B 1 PARA Approach Obstruction?	No	N/A	B 2 PARA Approach Obstruction?	N/A
APS Compliance				N/A B 1 PARA Approach Obstruction Dist (in) N/A	N/A	B 2 PARA Approach Obstruction Dist (in)) N/A
Is Button 1 APS or Non-APS?	NonAPS	Is Button 2 APS or Non-APS?	N/A	No B 1 Clear Floor Space Slope (%)	N/A	N/A	B 2 Clear Floor Space Slope (%)	N/A
N/A B 1 VibroTact Arrow?	N/A N/	A B 2 VibroTact Arrow?	N/A	No B 1 Clear Floor Space XSlope (%)	N/A	N/A	B 2 Clear Floor Space XSlope (%)	N/A
N/A B 1 VibroTact Parallel to Xing?	N/A N/	A B 2 VibroTact Parallel to Xing?	N/A	N/A B 1 PAR Slope (%)	N/A	N/A	B 2 PAR Slope (%)	N/A
N/A B 1 VibroTact Contrast	N/A N/	A B 2 VibroTact Contrast	N/A	Yes B 1 Height (in)	45.0	N/A	B 2 Height (in)	N/A
N/A B 1 Pilot Light?	N/A N/	A B 2 Pilot Light?	N/A	Yes B 1 Pressure (#)	2.0	N/A	B 2 Pressure (#)	N/A
N/A B 1 Pilot Light Illumination?	N/A N/	A B 2 Pilot Light Illumination?	N/A	Yes B 1 Closed Fist Operation?	Yes	N/A	B 2 Closed Fist Operation?	N/A

N/A B 1 Verbal Walk Cycle?	N/A N/	A B 2 Verbal Walk Cycle?	N/A	MUTCD Compliance				
N/A B 1 Verbal Message Audible?	N/A N/	A B 2 Verbal Message Audible?	N/A	N/A B 1 Clear Xing Direction?	Yes	N/A	B 2 Clear Xing Direction?	N/A
N/A B 1 Locator Tone?	N/A N/	A B 2 Locator Tone?	N/A	B 1 Crossing Direction	To NW		B 2 Crossing Direction	N/A
N/A B 1 Percussive Walk Cycle?	N/A N/	A B 2 Percussive Walk Cycle?	N/A	No B 1 DistanceTo XWalk (in)	89.0	N/A	B 2 DistanceTo XWalk (in)	N/A

Possible Solutions: Replace Signal Push Button With APS Button on New Post. Remove & Relocate Sign.

PROW/ADA: TMUTCD 4e.08, R404.3, R404.2, R404.7.3, R404.7.2
