Access Compliance Report

Public Rights-of-Way

(Pedestrian Signals)

Intersection ID: N/A	Main Street:	Cross Street: N/A	Location: N/A
ADA ID: 3D19DD16C6C3	Signal Type: One Push Button-APS	Overall Compliance: No	Severity Score: BTN 1: N/A BTN 2: N/A No BTN: N/A
Codes/Mitigation Info/Possible Solution		Field Measurements/Component Compliance

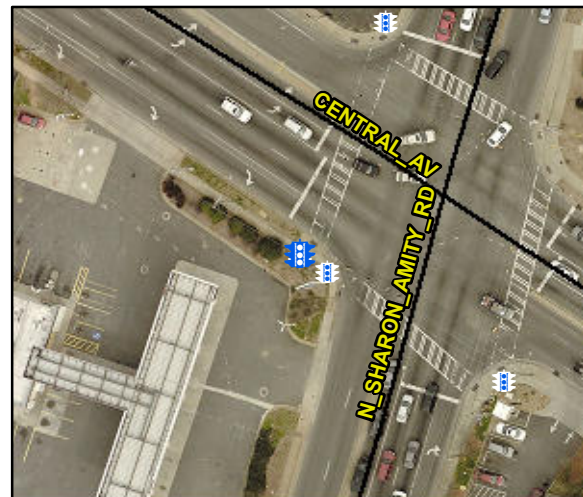
Surveyor Notes: TEXT HT 3/8, SIGNAL IS OUT OF SERVICE

PROW/ADA: R410.6, TMUTCD 4e.08, R404.2, R403.4, R209.1, TMUTCD 4e.10, MUTCD 4e.08, R104.2,

Possible Solutions: Replace Signal Push Button With APS Button on New Post. Remove & Replace Sign.

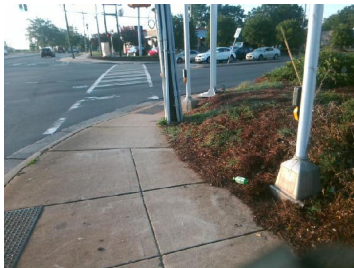
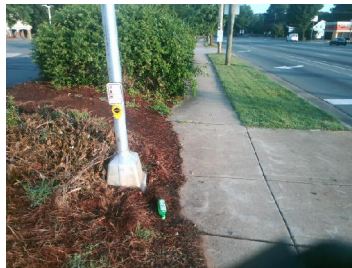
Compliance	Description	Data	Compliance	Description	Data
	Button Count	Button1	Yes	Distant to Additional Button (in)	177.0
	Additional Button Present?	Yes		Additional Button ID	A92A3716E293
N/A	Signal Buttons Required?	N/A	N/A	Additional Ped Posts Required	N/A
	How Many Ped Street Xings?	1		Located In An Island/Median?	No
N/A	B 1 Sign Present?	Yes	N/A	B 2 Sign Present?	N/A
Yes	B 1 Sign Purpose?	Yes	N/A	B 2 Sign Purpose?	N/A
No	B 1 Sign Lettering & Contrast?	No	N/A	B 2 Sign Lettering & Contrast?	N/A
Yes	B 1 Parallel To XWalk?	Yes	N/A	B 2 Parallel To XWalk?	N/A
Yes	B 1 PAR to Button?	Yes	N/A	B 2 PAR to Button?	N/A
Yes	B 1 PAR to XWalk?	Yes	N/A	B 2 PAR to XWalk?	N/A
Yes	B 1 Clear Floor Space?	Yes	N/A	B 2 Clear Floor Space?	N/A
N/A	B 1 FWD Approach?	No	N/A	B 2 FWD Approach?	N/A
N/A	B 1 FWD Approach Constrained?	N/A	N/A	B 2 FWD Approach Constrained?	N/A
N/A	B 1 FWD Approach Reach (in)	N/A	N/A	B 2 FWD Approach Reach (in)	N/A

N/A	B 1 FWD Approach Width (in)	N/A	N/A	B 2 FWD Approach Width (in)	N/A
N/A	B 1 FWD Approach Obstruction?	N/A	N/A	B 2 FWD Approach Obstruction?	N/A
N/A	B 1 FWD Approach Obstruction Dist (in)	N/A	N/A	B 2 FWD Approach ObstructionDist (in)	N/A
N/A	B 1 PARA Approach?	Yes	N/A	B 2 PARA Approach?	N/A
N/A	B 1 PARA Approach Constrained?	No	N/A	B 2 PARA Approach Constrained?	N/A
Yes	B 1 PARA Approach Reach (in)	8.0	N/A	B 2 PARA Approach Reach (in)	N/A
N/A	B 1 PARA Approach Width (in)	N/A	N/A	B 2 PARA Approach Width (in)	N/A
N/A	B 1 PARA Approach Obstruction?	Yes	N/A	B 2 PARA Approach Obstruction?	N/A
N/A	B 1 PARA Approach Obstruction Dist (in)	8.0	N/A	B 2 PARA Approach ObstructionDist (in)	N/A
Yes	B 1 Clear Floor Space Slope (%)	1.0	N/A	B 2 Clear Floor Space Slope (%)	N/A
No	B 1 Clear Floor Space XSlope (%)	2.1	N/A	B 2 Clear Floor Space XSlope (%)	N/A
N/A	B 1 PAR Slope (%)	3.2	N/A	B 2 PAR Slope (%)	N/A
Yes	B 1 Height (in)	37.0	N/A	B 2 Height (in)	N/A

No	B 1 Pressure (#)	N/A	N/A	B 2 Pressure (#)	N/A
Yes	B 1 Closed Fist Operation?	Yes	N/A	B 2 Closed Fist Operation?	N/A

Yes	B 1 Clear Xing Direction?	ClearlyMarked	N/A	B 2 Clear Xing Direction?	N/A
	B 1 Crossing Direction	To NE		B 2 Crossing Direction	N/A
Yes	B 1 DistanceTo XWalk (in)	0.0	N/A	B 2 DistanceTo XWalk (in)	N/A
No	B 1 DistanceTo Curb (in)	140.0	N/A	B 2 DistanceTo Curb (in)	N/A
Yes	B 1 Diameter (in)	2.0	N/A	B 2 Diameter (in)	N/A

Is Button 1 APS or Non-APS?	APS	Is Button 2 APS or Non-APS?	N/A
No	B 1 VibroTact Arrow?	No	N/A
N/A	B 1 VibroTact Parallel to Xing?	N/A	N/A
N/A	B 1 VibroTact Contrast	N/A	N/A
No	B 1 Pilot Light?	No	N/A
N/A	B 1 Pilot Light Illumination?	N/A	N/A
N/A	B 1 Verbal Walk Cycle?	No	N/A
N/A	B 1 Verbal Message Audible?	N/A	N/A
No	B 1 Locator Tone?	No	N/A
N/A	B 1 Percussive Walk Cycle?	No	N/A
No	B 1 Extended Press Feature?	No	N/A
No	B 1 Tone Audible Range?	N/A	N/A
