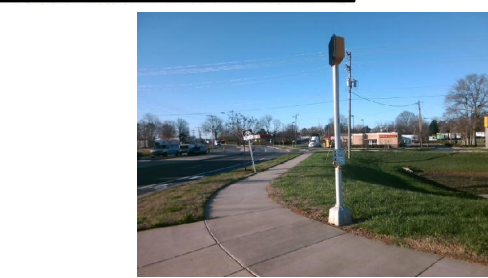
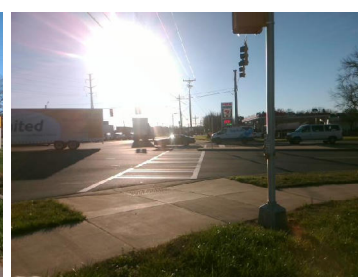
Total Cost: \$ 650.00							
APS Compliance				Compliance	Description	Data	Compliance
Is Button 1 APS or Non-APS?	NonAPS	Is Button 2 APS or Non-APS?	N/A		Button Count	Button1	
N/A B 1 VibroTact Arrow?	No	N/A B 2 VibroTact Arrow?	N/A		Additional Button Present?	No	
N/A B 1 VibroTact Parallel to Xing?	No	N/A B 2 VibroTact Parallel to Xing?	N/A	N/A	Signal Buttons Required?	N/A	N/A
N/A B 1 VibroTact Contrast	No	N/A B 2 VibroTact Contrast	N/A		How Many Ped Street Xings?	N/A	
N/A B 1 Pilot Light?	No	N/A B 2 Pilot Light?	N/A	N/A	B 1 Sign Present?	Yes	N/A
N/A B 1 Pilot Light Illumination?	No	N/A B 2 Pilot Light Illumination?	N/A	Yes	B 1 Sign Purpose?	Yes	N/A
N/A B 1 Verbal Walk Cycle?	No	N/A B 2 Verbal Walk Cycle?	N/A	Yes	B 1 Sign Lettering & Contrast?	Yes	N/A

N/A B 1 Verbal Message Audible?	No	N/A B 2 Verbal Message Audible?	N/A	Yes	B 1 Parallel To XWalk?	Yes	N/A
N/A B 1 Locator Tone?	No	N/A B 2 Locator Tone?	N/A	Yes	B 1 PAR to Button?	Yes	N/A
N/A B 1 Percussive Walk Cycle?	No	N/A B 2 Percussive Walk Cycle?	N/A	Yes	B 1 PAR to XWalk?	Yes	N/A
N/A B 1 Extended Press Feature?	No	N/A B 2 Extended Press Feature?	N/A	Yes	B 1 Clear Floor Space?	Yes	N/A
N/A B 1 Tone Audible Range?	No	N/A B 2 Tone Audible Range?	N/A	N/A	B 1 FWD Approach?	No	N/A
				N/A	B 1 FWD Approach Constrained?	No	N/A
				N/A	B 1 FWD Approach Reach (in)	N/A	N/A
				N/A	B 1 FWD Approach Width (in)	N/A	N/A
				N/A	B 1 FWD Approach Obstruction?	Yes	N/A
				N/A	B 1 FWD Approach Obstruction Dist (in)	5.0	N/A
				N/A	B 1 PARA Approach?	Yes	N/A
				N/A	B 1 PARA Approach Constrained?	Yes	N/A
				Yes	B 1 PARA Approach Reach (in)	7.0	N/A
				No	B 1 PARA Approach Width (in)	48.0	N/A
				N/A	B 1 PARA Approach Obstruction?	Yes	N/A

N/A	B 1 PARA Approach Obstruction Dist (in)	6.0	N/A
				Yes	B 1 Clear Floor Space Slope (%)	0.9	N/A
				No	B 1 Clear Floor Space XSlope (%)	2.8	N/A
				N/A	B 1 PAR Slope (%)	1.7	N/A
				Yes	B 1 Height (in)	41.0	N/A
				Yes	B 1 Pressure (#)	2.0	N/A
				Yes	B 1 Closed Fist Operation?	Yes	N/A
				MUTCD Compliance			
				N/A	B 1 Clear Xing Direction?	N/A	N/A
					B 1 Crossing Direction	To SE	
				Yes	B 1 DistanceTo XWalk (in)	0.0	N/A
				No	B 1 DistanceTo Curb (in)	174.0	N/A
				Yes	B 1 Diameter (in)	2.0	N/A

Possible Solutions: Replace Signal Push Button With APS Button on New Post. Remove & Relocate Sign.			
Surveyor Notes: N/A				PROW/ADA: TMUTCD 4e.08, R404.2, R404.7.2
