# Access Compliance Report

## Public Rights-of-Way

### (Pedestrian Signals)

| ADA ID: 5DEE9B443E22 | Signal Type: Two Push Buttons-Non APS | Overall Compliance: No | Severity Score: BTN 1:N/A BTN 2: N/A No BTN: N/A |

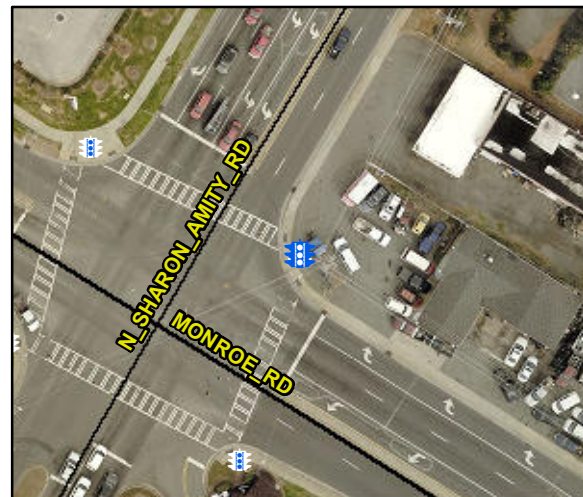
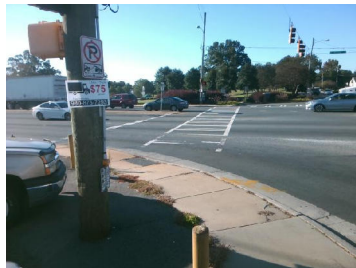
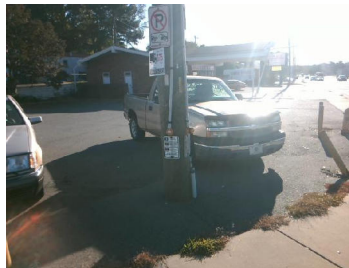
| Compliance | Description | Data | Compliance | Description | Data |
|---|---|---|---|---|---|
| No | B 1 Clear Floor Space XSlope (%) | 3.4 | No | B 2 Clear Floor Space XSlope (%) | 4.2 |

| No | B 1 DistanceTo Curb (in) | 116.0 | No | B 2 DistanceTo Curb (in) | 146.0 |

Possible Solutions: Replace Signal Push Button With APS Button on New Post. Remove & Relocate Sign.

PROW/ADA: TMUTCD 4e.08, R404.2

Total Cost: \$ 1300.00
