## Access Compliance Report Public Rights-of-Way (Pedestrian Signals)

ADA ID: 68D035D60F55 Signal Type: One Push Button-Non APS Overall Compliance: No Severity Score: BTN 1:N/A BTN 2: N/A No BTN: N/A

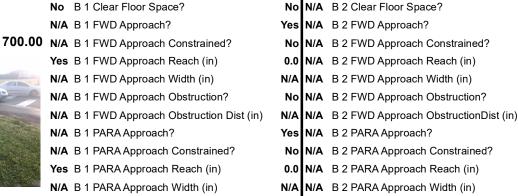
Surveyor Notes: TEXT HT 7/16, NO SIDEWALK AROUND SIGNAL

Possible Solutions: Replace Signal Push Button With APS Button on New Post. Remove & Replace Sign.
