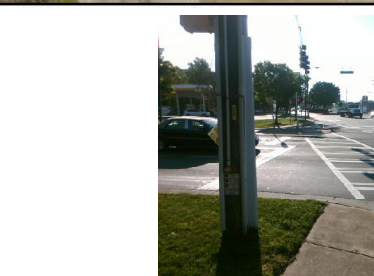
Surveyor Notes: N/A		PROW/ADA: TMUTCD 4e.08, R404.1, R404.7.1, R404.7.2	
Total Cost:		\$ 650.00			
APS Compliance					
Is Button 1 APS or Non-APS?	NonAPS	Is Button 2 APS or Non-APS?	N/A		
N/A B 1 VibroTact Arrow?	No	N/A B 2 VibroTact Arrow?	N/A		
N/A B 1 VibroTact Parallel to Xing?	No	N/A B 2 VibroTact Parallel to Xing?	N/A		
N/A B 1 VibroTact Contrast	No	N/A B 2 VibroTact Contrast	N/A		
N/A B 1 Pilot Light?	No	N/A B 2 Pilot Light?	N/A		
N/A B 1 Pilot Light Illumination?	No	N/A B 2 Pilot Light Illumination?	N/A		
N/A B 1 Verbal Walk Cycle?	No	N/A B 2 Verbal Walk Cycle?	N/A		
N/A B 1 Verbal Message Audible?	No	N/A B 2 Verbal Message Audible?	N/A		
N/A B 1 Locator Tone?	No	N/A B 2 Locator Tone?	N/A		
N/A B 1 Percussive Walk Cycle?	No	N/A B 2 Percussive Walk Cycle?	N/A		
N/A B 1 Extended Press Feature?	No	N/A B 2 Extended Press Feature?	N/A

N/A B 1 Tone Audible Range?	No	N/A B 2 Tone Audible Range?	N/A		
MUTCD Compliance					
Is Button 1 APS or Non-APS?	NonAPS	Is Button 2 APS or Non-APS?	N/A		
N/A B 1 VibroTact Arrow?	No	N/A B 2 VibroTact Arrow?	N/A		
N/A B 1 VibroTact Parallel to Xing?	No	N/A B 2 VibroTact Parallel to Xing?	N/A		
N/A B 1 VibroTact Contrast	No	N/A B 2 VibroTact Contrast	N/A		
N/A B 1 Pilot Light?	No	N/A B 2 Pilot Light?	N/A		
N/A B 1 Pilot Light Illumination?	No	N/A B 2 Pilot Light Illumination?	N/A		
N/A B 1 Verbal Walk Cycle?	No	N/A B 2 Verbal Walk Cycle?	N/A		
N/A B 1 Verbal Message Audible?	No	N/A B 2 Verbal Message Audible?	N/A		
N/A B 1 Locator Tone?	No	N/A B 2 Locator Tone?	N/A		
N/A B 1 Percussive Walk Cycle?	No	N/A B 2 Percussive Walk Cycle?	N/A		
N/A B 1 Extended Press Feature?	No	N/A B 2 Extended Press Feature?	N/A		
N/A B 1 Tone Audible Range?	No	N/A B 2 Tone Audible Range?	N/A

Possible Solutions: Replace Signal Push Button With APS Button on New Post. Remove & Relocate Sign.
