# Access Compliance Report

## Public Rights-of-Way

### (Pedestrian Signals)

| ADA ID: 8CFA13814041 | Signal Type: Two Push Buttons-APS | Overall Compliance: No | Severity Score: BTN 1:N/A BTN 2: N/A No BTN: N/A |

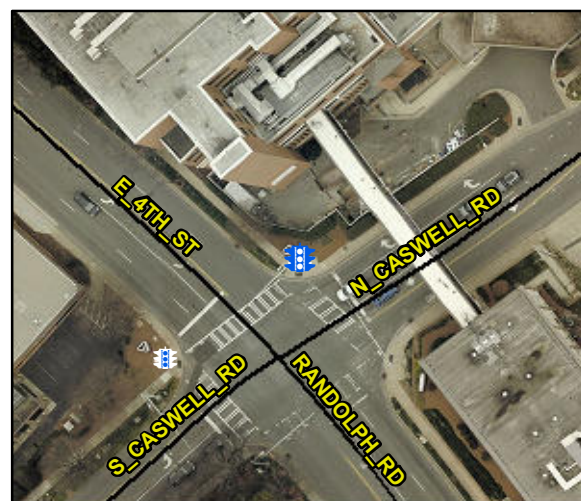
Surveyor Notes: B1 OUT OF SERVICE

| Compliance | Description | Data | Compliance | Description | Data |
|---|---|---|---|---|---|
| No | B 1 Clear Floor Space Slope (%) | 7.3 | Yes | B 2 Clear Floor Space Slope (%) | 8.4 |

| Yes | B 1 DistanceTo XWalk (in) | 0.0 | No | B 2 DistanceTo XWalk (in) | 79.0 |
| No | B 1 DistanceTo Curb (in) | 98.0 | No | B 2 DistanceTo Curb (in) | 96.0 |

Possible Solutions: Replace Signal Push Button With APS Button on New Post. Remove & Relocate Sign.

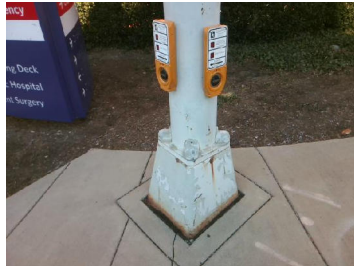
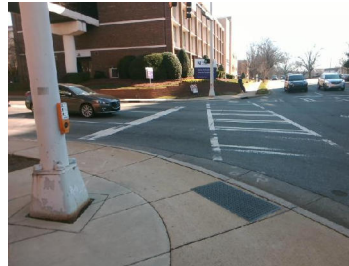
| No | B 1 VibroTact Arrow? | No | Yes |
| No | B 1 Pilot Light? | No | Yes |
| No | B 1 Locator Tone? | No | Yes |
| No | B 1 Extended Press Feature? | No | Yes |
