Access Compliance Report

Public Rights-of-Way

(Pedestrian Signals)

| ADA ID: 8D4F509E710E | Signal Type: One Push Button-APS | Overall Compliance: No | Severity Score: BTN 1: N/A BTN 2: N/A No BTN: N/A |

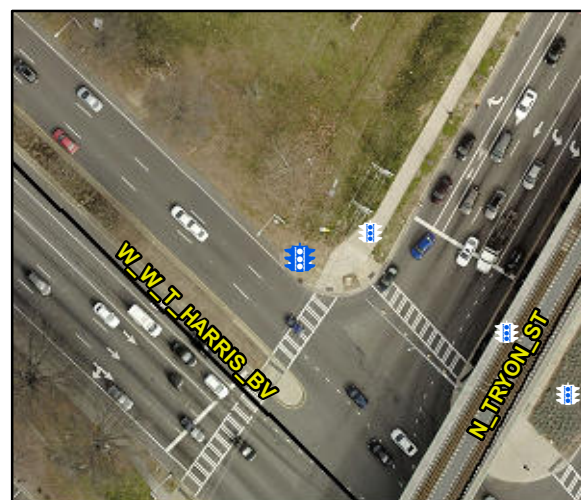
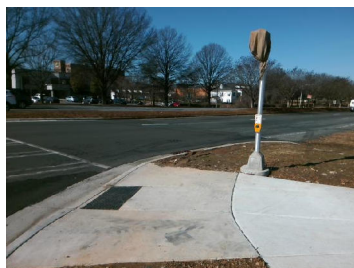
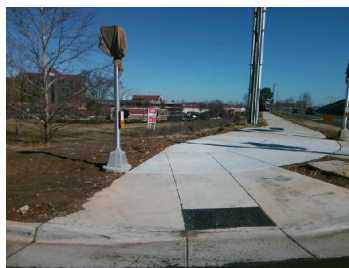
Surveyor Notes: NOT HOOKED UP, NOISES AND VERBAL COMMANDS UNKNOWN

| Compliance | Description | Data | Compliance | Description | Data |
|---|---|---|---|--|---|
| No | B 1 PARA Approach Width (in) | 48.0 | N/A | B 2 PARA Approach Width (in) | N/A |
| No | B 1 Closed Fist Operation? | N/A | N/A | B 2 Closed Fist Operation? | N/A |

| No | B 1 DistanceTo Curb (in) | 93.0 | N/A | B 2 DistanceTo Curb (in) | N/A |

Possible Solutions: Replace Signal Push Button With APS Button on New Post. Remove & Relocate Sign.
