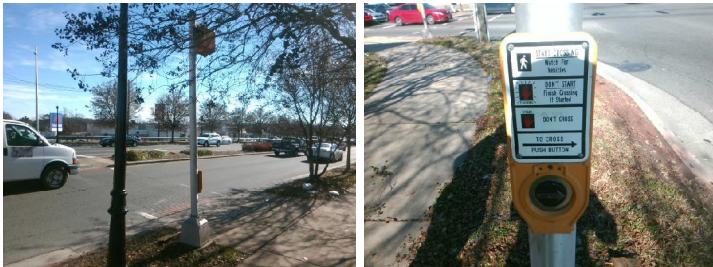
APS Compliance			
Is Button 1 APS or Non-APS?	APS	Is Button 2 APS or Non-APS?	N/A
Yes B 1 VibroTact Arrow?	Yes	N/A B 2 VibroTact Arrow?	N/A
Yes B 1 VibroTact Parallel to Xing?	Yes	N/A B 2 VibroTact Parallel to Xing?	N/A
Yes B 1 VibroTact Contrast	Yes	N/A B 2 VibroTact Contrast	N/A
Yes B 1 Pilot Light?	Yes	N/A B 2 Pilot Light?	N/A
Yes B 1 Pilot Light Illumination?	Yes	N/A B 2 Pilot Light Illumination?	N/A
No B 1 Verbal Walk Cycle?	Yes	N/A B 2 Verbal Walk Cycle?	N/A
N/A B 1 Verbal Message Audible?	Yes	N/A B 2 Verbal Message Audible?	N/A
Yes B 1 Locator Tone?	Yes	N/A B 2 Locator Tone?	N/A
Yes B 1 Percussive Walk Cycle?	Yes	N/A B 2 Percussive Walk Cycle?	N/A
Yes B 1 Extended Press Feature?	Yes	N/A B 2 Extended Press Feature?	N/A
Yes B 1 Tone Audible Range?	Yes	N/A B 2 Tone Audible Range?	N/A

MUTCD Compliance			
Yes B 1 Clear Xing Direction?	ClearlyMarked	N/A B 2 Clear Xing Direction?	N/A
B 1 Crossing Direction	To E	B 2 Crossing Direction	N/A
Yes B 1 DistanceTo XWalk (in)	31.0	N/A B 2 DistanceTo XWalk (in)	N/A
Yes B 1 DistanceTo Curb (in)	40.0	N/A B 2 DistanceTo Curb (in)	N/A
Yes B 1 Diameter (in)	2.0	N/A B 2 Diameter (in)	N/A

**Possible Solutions: Remove & Replace  
Replace APS Button With New APS Button.  
Provide PAR As Indicated. Remove and  
Replace Clear Space.**
