Access Compliance Report

Public Rights-of-Way

(Island Curb Cuts)

Intersection ID: 10037033	Main Street: S_TRYON_ST	Cross Street: N/A	Location:	W
ADA ID: 2BCBD790206A	Curb Cut Type: MedianRefuge2	Initial Pass/Fail: Pass	Overall Compliance: No	Severity Score: 0

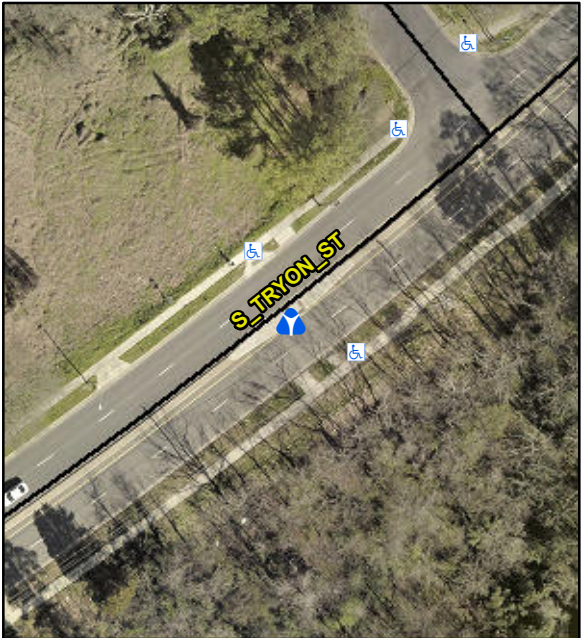
Possible Solutions:		Compliance	Description	Data	
	Remove & Replace Gutter.		Yes	Refuge 1 Length (In)	48.0	N/A
			Yes	Refuge 1 Width (In)	96.0	N/A
			Yes	Refuge 1 Slope (%)	1.8	N/A
			Yes	Refuge 1 X Slope (%)	0.8	N/A
			N/A	Painted X Walk1?	No	Yes
			N/A	X Walk 1 Direction	To SE	Yes
			N/A	X Walk 1 Width (In)	N/A	Yes
			N/A	Road 1 Slope (%)	0.8	Yes
			N/A	Road 1 X Slope (%)	4.3	Yes
<p>Surveyor Notes:</p> <p>N/A</p>			Yes	Refuge 2 Length (In)	48.0	Yes
			Yes	Refuge 2 Width (In)	96.0	Yes
			Yes	Refuge 2 Slope (%)	1.4	No
			Yes	Refuge 2 X Slope (%)	0.2	No
			N/A	Painted X Walk2?	No	Yes
			N/A	X Walk 2 Direction	To NW	Yes
			N/A	X Walk 2 Width (In)	N/A	Yes
			N/A	Road 2 Slope (%)	0.3	Yes
			N/A	Road 2 X Slope (%)	3.7	Yes
			N/A	Refuge 3 Length (in)	N/A	N/A
<p>PROW/ADA:</p> <p>N/A</p>			N/A	Refuge 3 Width (in)	N/A	N/A
			N/A	Refuge 3 Slope (%)	N/A	N/A

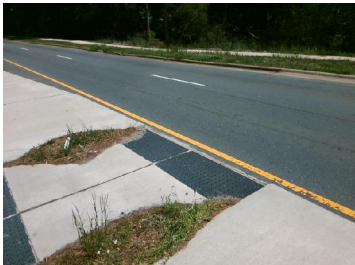
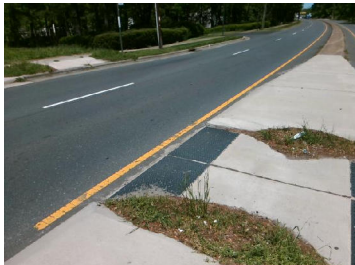
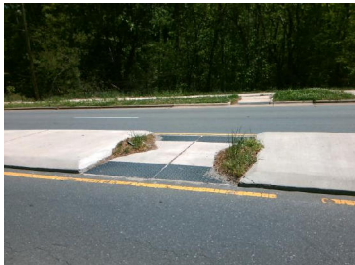
N/A	Refuge 3 XSlope (%)	N/A	N/A
			N/A	Painted X Walk3?	N/A	N/A
			N/A	X Walk 3 Direction	N/A	N/A
			N/A	X Walk 3 Width (in)	N/A	N/A
			N/A	Road 3 Slope (%)	N/A	N/A
			N/A	Road 3 XSlope (%)	N/A	N/A
			Yes	Any Obstructions?	N/A	N/A
			N/A	Obstruction Type	N/A	N/A
<p>Total Cost:</p> <p>\$ 750.00</p>			N/A	Storm Grate/Utility Hazard?	No	N/A
			N/A	Storm Grate/Utility Type	N/A	N/A
			N/A		N/A	N/A
			N/A	Surface Condition	Good	N/A
