# Access Compliance Report Public Rights-of-Way (Transit Stops)

| Intersection ID: 28536 | Main Street: SOUTH_STREAM_BV | Cross Street: W_TYVOLA_RD | Location: W |
| ADA ID: 02A6F75C6774 | Overall Compliance: No | Severity Score: 80 | |

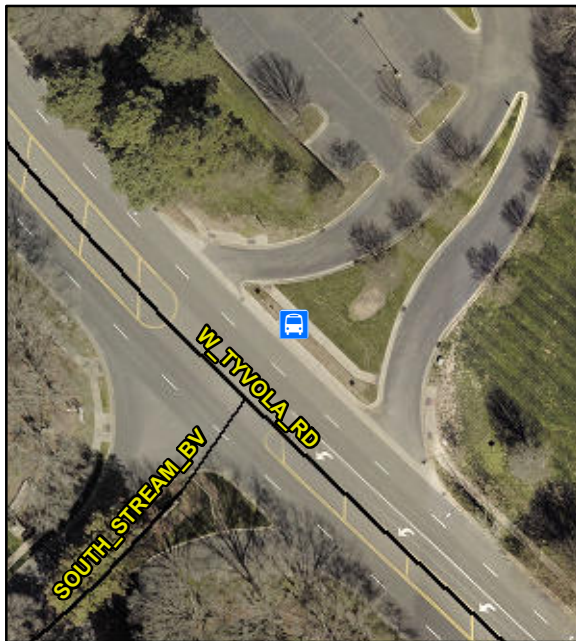
| Compliance | Description | Data |
|---|---|---|
| No | Boarding Area | No |
| No | PAR 2 XSlope % | 2.2 |
| No | Boarding Area Connected to PAR? | No |

**Provide Boarding Area. Remove & Replace Sidewalk To Boarding Area.**
