# Access Compliance Report

## Public Rights-of-Way

### (Transit Stops)

| Intersection ID: 10158 | Main Street: MULBERRY_CHURCH_RD | Cross Street: TUCKASEEGEE_RD | Location: NE |

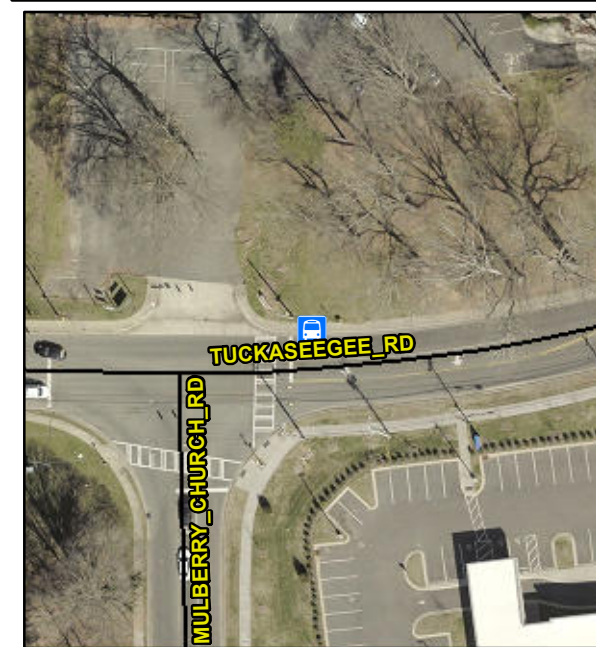
| Compliance | Description | Data |
|---|---|---|
| No | Boarding Area Length (in) | 66.0 |
| No | Boarding Area Slope % | 4.2 |
| No | PAR 1 Exist? | Yes |
| No | PAR 1 XSlope % | 4.2 |

**Remove & Replace Boarding Area.  
Remove & Replace Sidewalk To  
Boarding Area. Remove or Relocate  
Protruding Objects/Obstructions.**

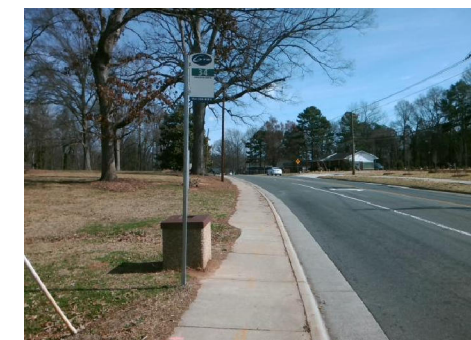
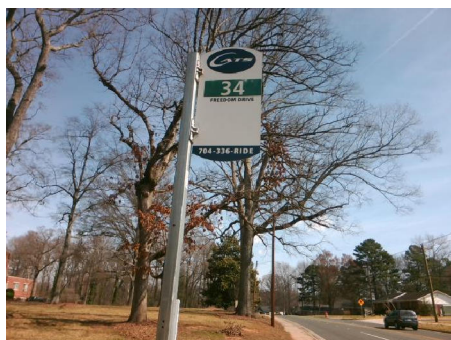
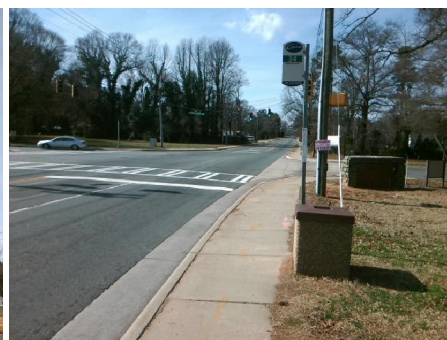
| Compliance | Description | Data |
|---|---|---|
| No | Protruding Objects? | Yes |
