# Access Compliance Report Public Rights-of-Way (Transit Stops)

| Intersection ID: 10038355 | Main Street: SOUTH_BV | Cross Street: N/A | Location: E |
| ADA ID: 130A6C51ED0C | Overall Compliance: No | Severity Score: 80 | |

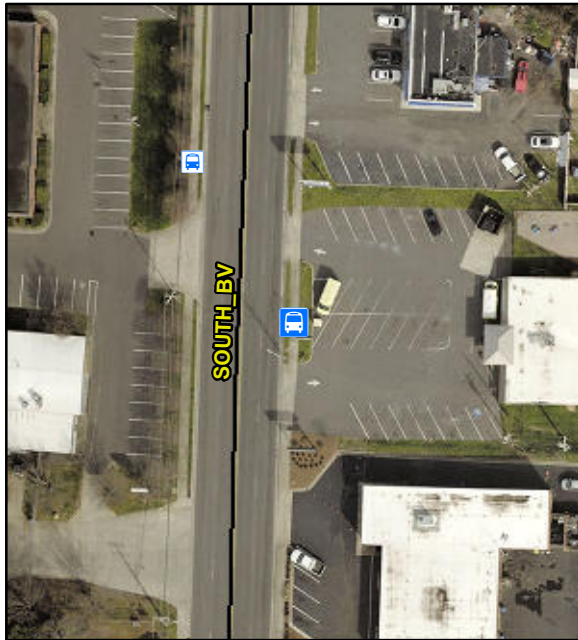
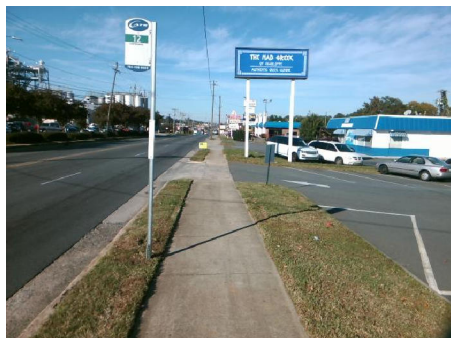
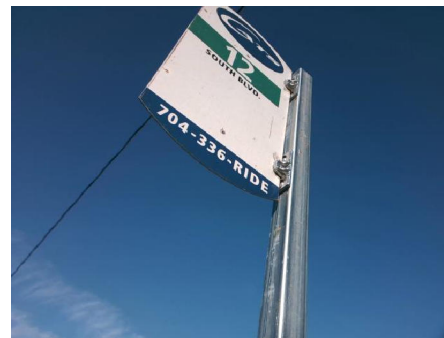
| Compliance | Description | Data |
|---|---|---|
| No | Boarding Area | No |
| No | PAR 1 Exist? | Yes |
| No | PAR 1 XSlope % | 2.3 |
| No | Boarding Area Connected to PAR? | No |

Possible Solutions:

**Provide Boarding Area. Remove & Replace Sidewalk To Boarding Area.**
