# Access Compliance Report Public Rights-of-Way (Transit Stops)

| Intersection ID: 10035417 | Main Street: RANDOLPH_RD | Cross Street: N/A | Location: NE |
| ADA ID: 16D3026888D2 | Overall Compliance: No | Severity Score: 20 | |

CATS Stop Description: **Randolph Rd & Cranbrook Ln**

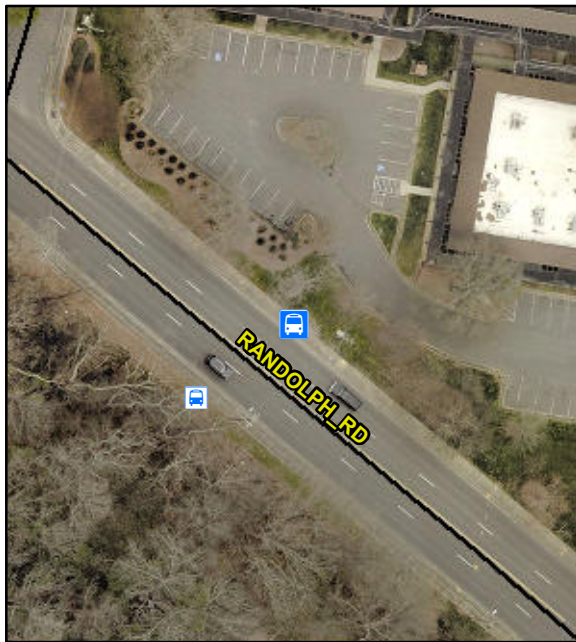
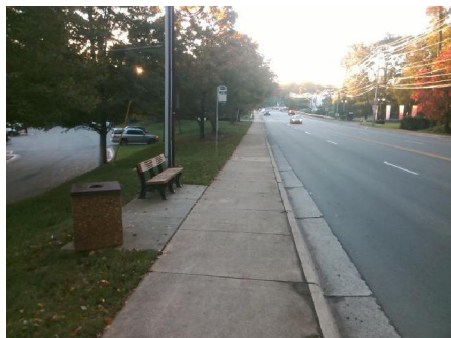
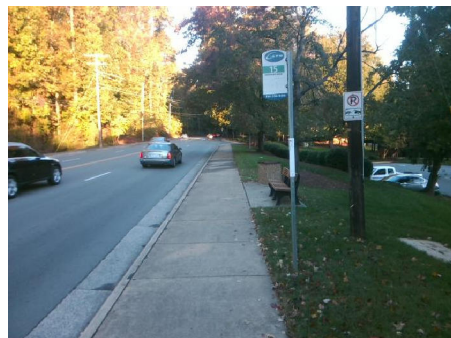
| Compliance | Description | Data |
|---|---|---|
| No | Boarding Area XSlope % | 3.7 |
| No | PAR 1 XSlope % | 2.2 |
| No | PAR 2 XSlope % | 2.2 |
| No | Clear Floor Space | Yes |
| No | Clear Floor Space XSlope % | 5.0 |
| No | Protruding Objects? | Yes |

**Remove & Replace Boarding Area.  
Remove & Replace Sidewalk To  
Boarding Area. Remove & Replace  
Clear Floor Space. Remove or  
Relocate Protruding  
Objects/Obstructions.**
