# Access Compliance Report Public Rights-of-Way (Transit Stops)

| Intersection ID: 9223 | Main Street: HILO_DR | Cross Street: N_TRYON_ST | Location: NW |
| ADA ID: 1B62B5BB1329 | Overall Compliance: No | Severity Score: 20 | |

CATS Stop ID: **18610**  
CATS Stop Description: **Tryon St & Hilo Dr**  
CATS Route ID: **11**  
CATS Route Name: **North Tryon**

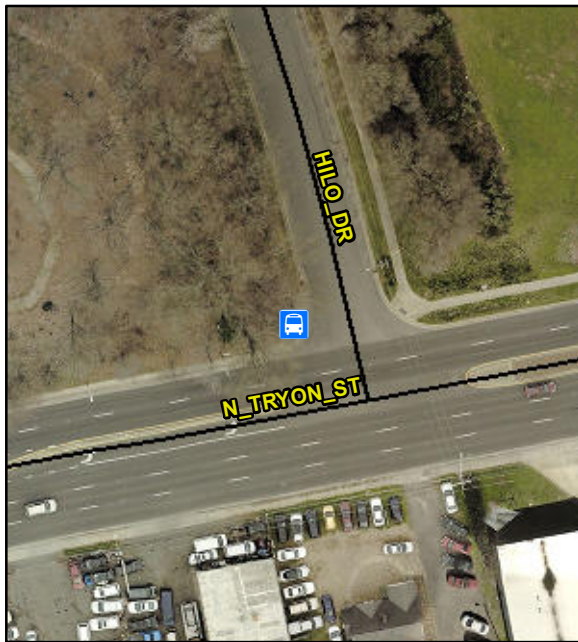
| Compliance | Description | Data |
|---|---|---|
| No | Boarding Area Length (in) | 60.0 |
| No | Boarding Area XSlope % | 2.6 |
| No | PAR 1 Exist? | Yes |
| No | PAR 1 Slope % | 4.1 |

**Remove & Replace Boarding Area.  
Remove & Replace Sidewalk To  
Boarding Area. Remove & Replace  
Clear Floor Space. Remove or  
Relocate Protruding  
Objects/Obstructions.**

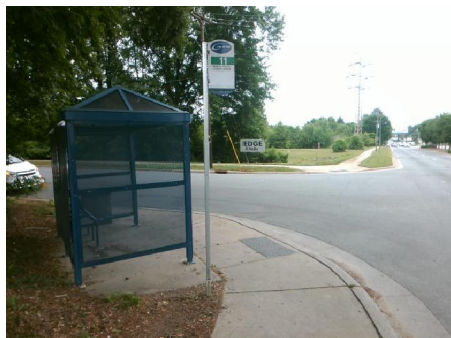
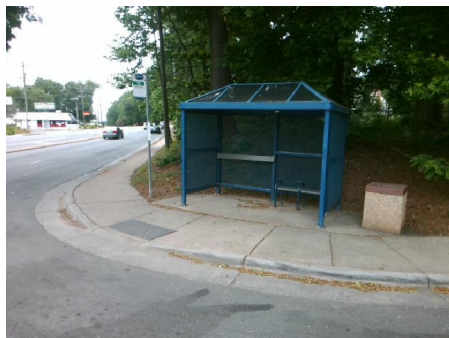
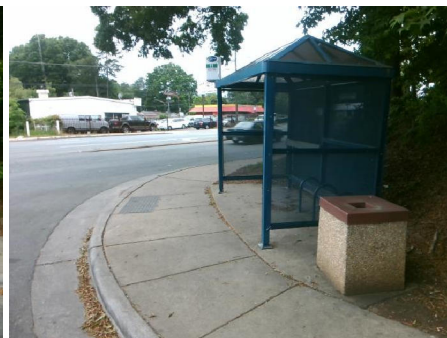
| Compliance | Description | Data |
|---|---|---|
| No | Clear Floor Space XSlope % | 2.7 |
| No | Protruding Objects? | Yes |
