# Access Compliance Report Public Rights-of-Way (Transit Stops)

| Intersection ID: 10037824 | Main Street: SHARON_RD_WEST | Cross Street: N/A | Location: N |
| ADA ID: 2B6F8B399B9B | Overall Compliance: No | Severity Score: 30 | |

CATS Stop Description: **Sharon Rd West & Sharon Lakes Rd**

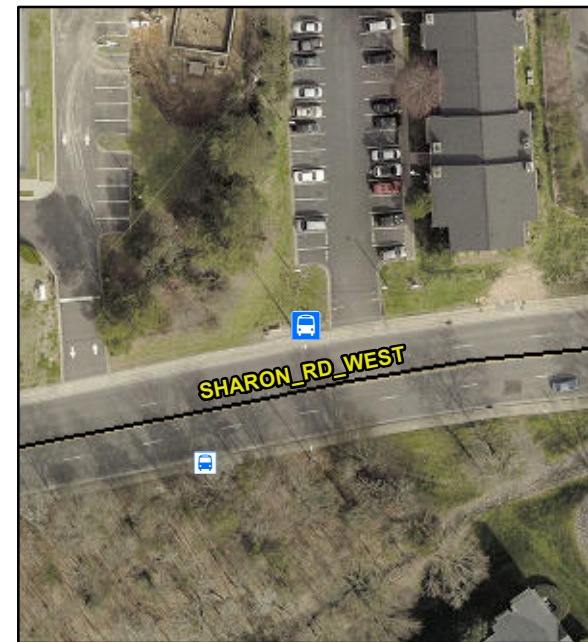
| Compliance | Description | Data |
|---|---|---|
| No | Boarding Area Slope % | 4.0 |
| No | Boarding Area XSlope % | 8.6 |
| No | PAR 1 Slope % | 8.6 |
| No | PAR 1 XSlope % | 4.0 |

**Remove & Replace Boarding Area.  
Remove & Replace Sidewalk To  
Boarding Area. Remove & Replace  
Clear Floor Space. Remove or  
Relocate Protruding  
Objects/Obstructions.**

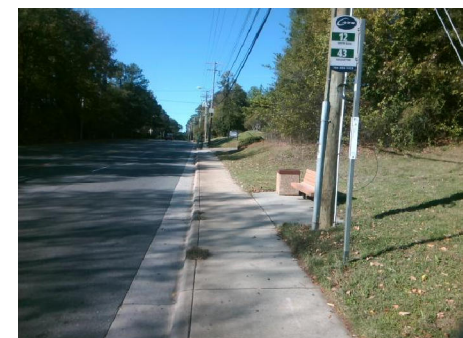
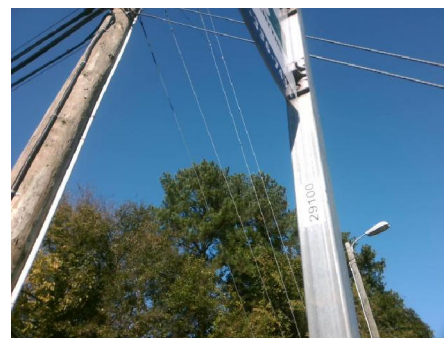
| Compliance | Description | Data |
|---|---|---|
| No | PAR 2 XSlope % | 2.8 |
| No | Clear Floor Space | Yes |
| No | Clear Floor Space Slope % | 2.7 |
| No | Clear Floor Space XSlope % | 5.8 |
| No | Protruding Objects? | Yes |
