# Access Compliance Report

## Public Rights-of-Way

### (Transit Stops)

| Intersection ID: 10017837 | Main Street: TRYON-CHURCH_CONNECTOR_ST | Cross Street: N/A | Location: N |

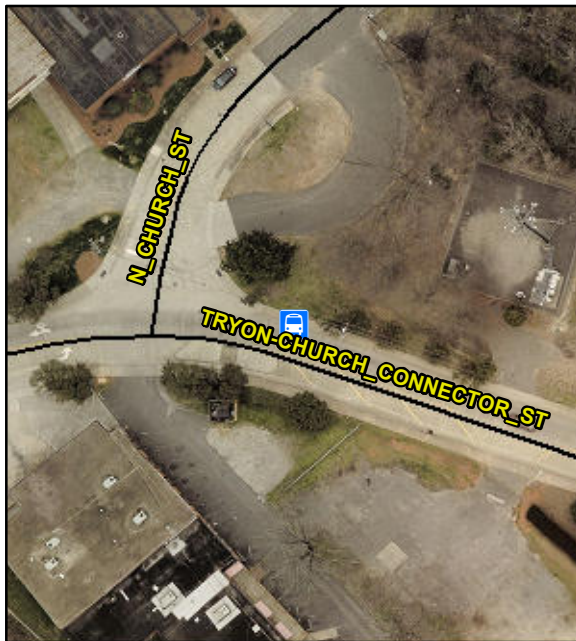
**810.2.2, R308.1.1.1**

| Compliance | Description | Data |
|---|---|---|
| No | Boarding Area Length (in) | 66.0 |

**Remove & Replace Boarding Area.**

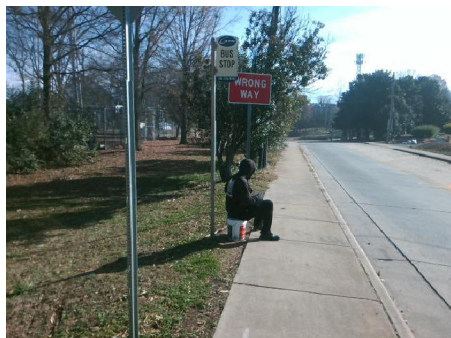
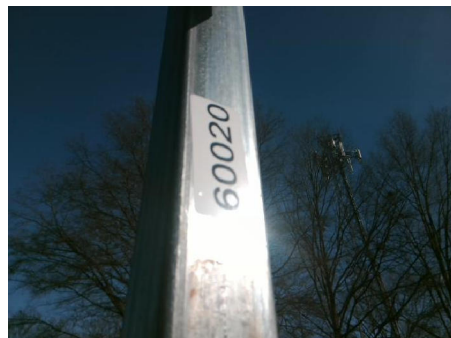
| Intersection ID: 10017837 | Main Street: TRYON-CHURCH_CONNECTOR_ST | Cross Street: N/A | Location: N |
|---|---|---|---|
| ADA ID: 40B638B57713 | Overall Compliance: No | Severity Score: 45 | |
