# Access Compliance Report Public Rights-of-Way (Transit Stops)

| Intersection ID: 1001922 | Main Street: PROSPERITY_CHURCH_RD | Cross Street: N/A | Location: S |
| ADA ID: 437C7D4252E8 | Overall Compliance: No | Severity Score: 85 | |

CATS Stop Description: **Prosperity Church Rd & Driwood Ct**

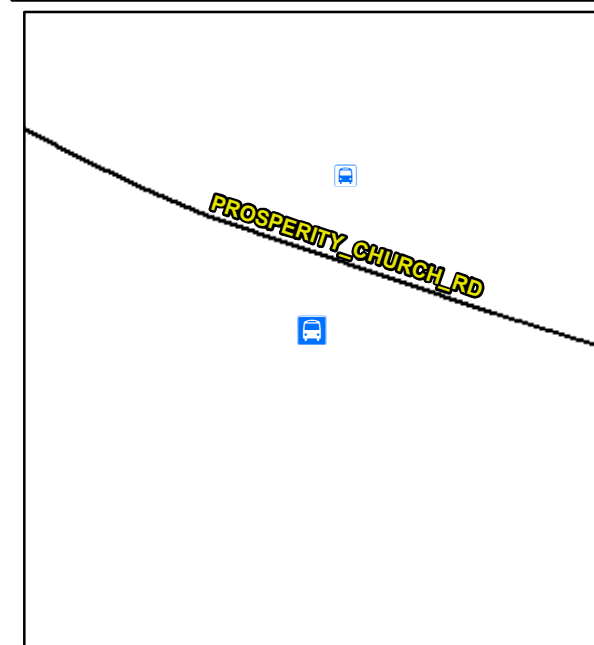
| Compliance | Description | Data |
|---|---|---|
| No | Boarding Area | No |
| No | PAR 1 Exist? | Yes |
| No | PAR 1 Slope % | 2.7 |
| No | Boarding Area Connected to PAR? | No |

**Provide Boarding Area. Remove & Replace Sidewalk To Boarding Area.**
