# Access Compliance Report Public Rights-of-Way (Transit Stops)

| Intersection ID: 10040761 | Main Street: W_TYVOLA_RD | Cross Street: N/A | Location: E |
| ADA ID: 43FDAA52CE2E | Overall Compliance: No | Severity Score: 85 | |

CATS Stop Description: **Tyvola Rd @ Renaissance Golf Course**

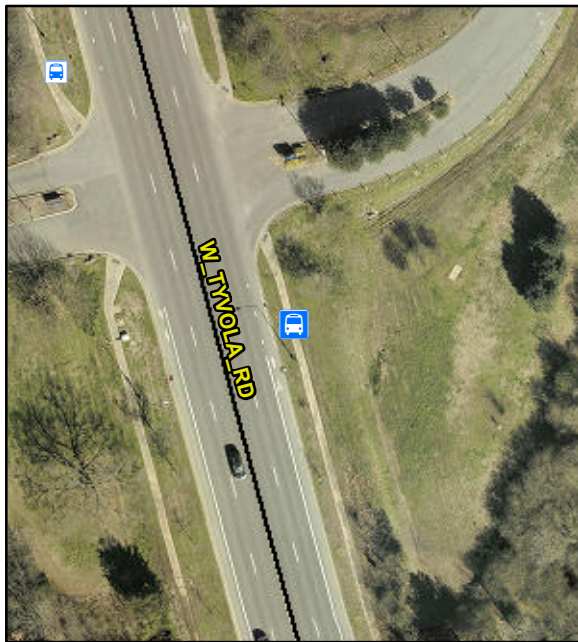
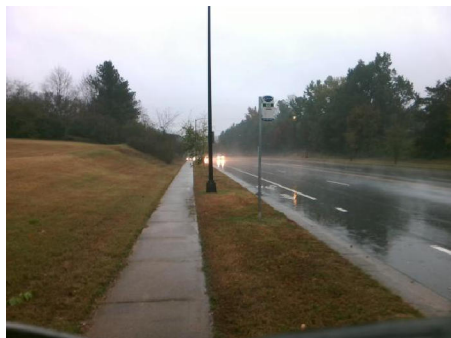
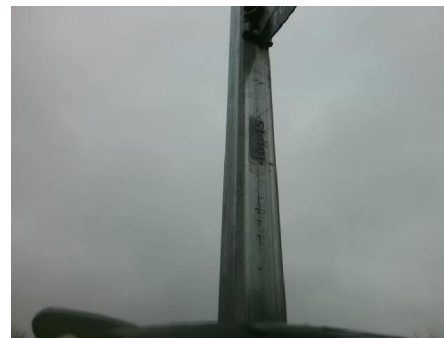
| Compliance | Description | Data |
|---|---|---|
| No | Boarding Area | No |
| No | PAR 1 Exist? | Yes |
| No | PAR 1 Width (in) | 47.0 |
| No | PAR 1 Slope % | 2.1 |
| No | PAR 1 XSlope % | 2.7 |
| No | PAR 2 Exist? | Yes |
| No | PAR 2 XSlope % | 3.0 |
| No | Boarding Area Connected to PAR? | No |

**Provide Boarding Area. Remove & Replace Sidewalk To Boarding Area.**
