# Access Compliance Report

## Public Rights-of-Way

### (Transit Stops)

| Intersection ID: 1001922 | Main Street: PROSPERITY_CHURCH_RD | Cross Street: N/A | Location: N |

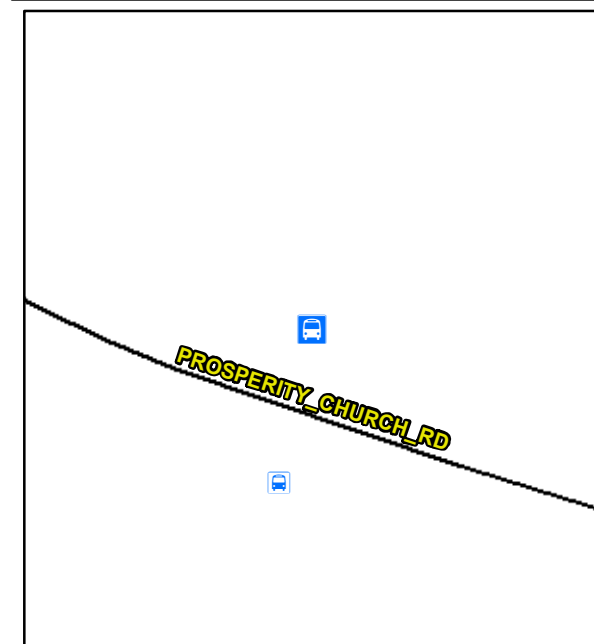
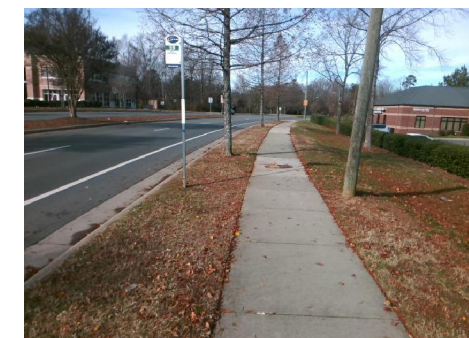
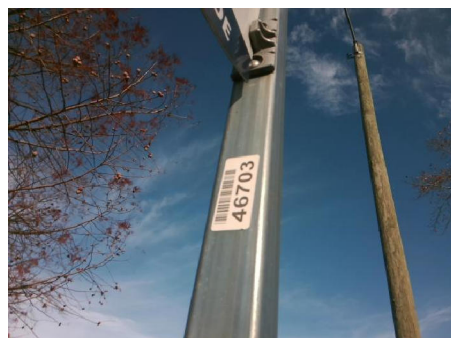
| ADA ID: 453D790BD065 | Overall Compliance: No | Severity Score: 80 | |

**810.2, 810.2.3, R302, R308.1.1**

| Compliance | Description | Data |
|---|---|---|
| No | Boarding Area | No |
| No | Boarding Area Connected to PAR? | No |

**Provide Boarding Area. Provide Sidewalk Connection to Boarding Area.**
