# Access Compliance Report

## Public Rights-of-Way

### (Transit Stops)

| Intersection ID: 23827 | Main Street: CULP_RD | Cross Street: E_WESTINGHOUSE_BV | Location: N |

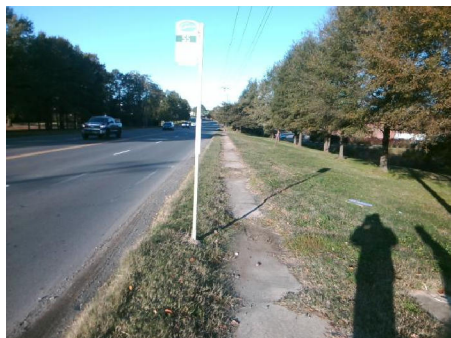
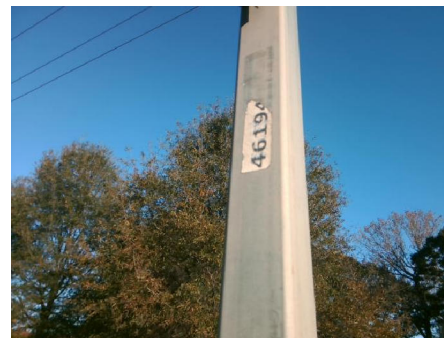
| Compliance | Description | Data |
|---|---|---|
| No | Boarding Area | No |
| No | Boarding Area Connected to PAR? | No |

**Provide Boarding Area. Provide Sidewalk Connection to Boarding Area.**
