# Access Compliance Report Public Rights-of-Way (Transit Stops)

| Intersection ID: 10016669 | Main Street: CINDY_LN | Cross Street: N/A | Location: S |
| ADA ID: 46CCFBA6294B | Overall Compliance: No | Severity Score: 75 | |

CATS Stop Description: **Cindy Ln & Belmar Place Rd**

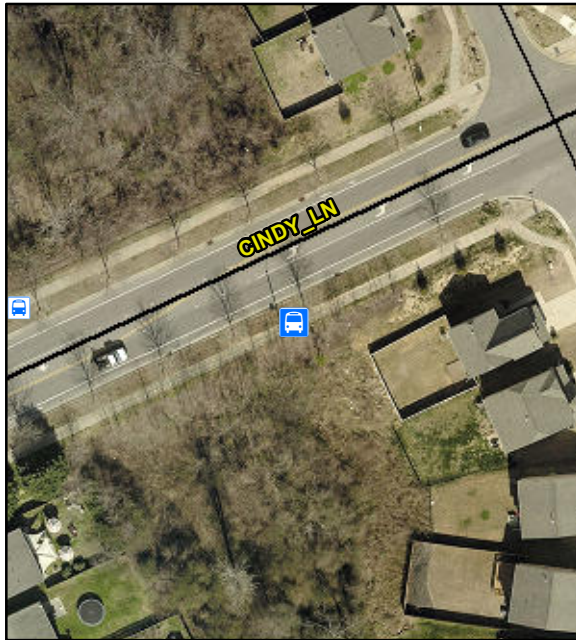
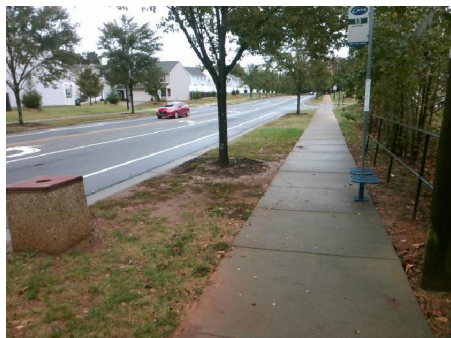
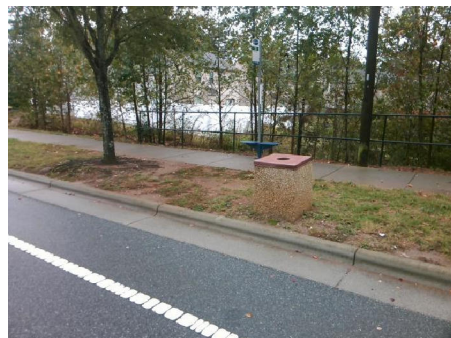
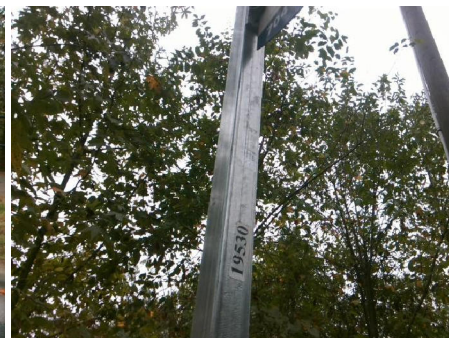
| Compliance | Description | Data |
|---|---|---|
| No | Boarding Area | No |
| No | Boarding Area Connected to PAR? | No |
| No | Clear Floor Space | No |
| No | Protruding Objects? | Yes |

**Provide Boarding Area. Provide Sidewalk Connection to Boarding Area. Provide Clear Floor Space. Remove or Relocate Protruding Objects/Obstructions.**
