# Access Compliance Report Public Rights-of-Way (Transit Stops)

| Intersection ID: 10040687 | Main Street: W_MOREHEAD_ST | Cross Street: N/A | Location: N |
| ADA ID: 495C324399BF | Overall Compliance: No | Severity Score: 20 | |

CATS Stop Description: **Morehead St & Millerton Av**

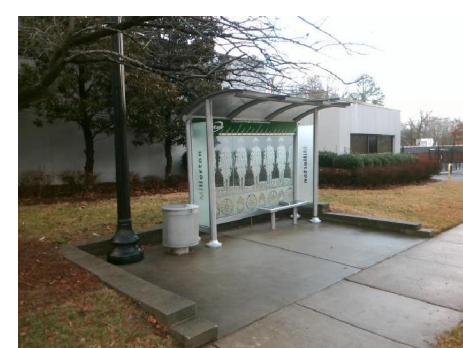
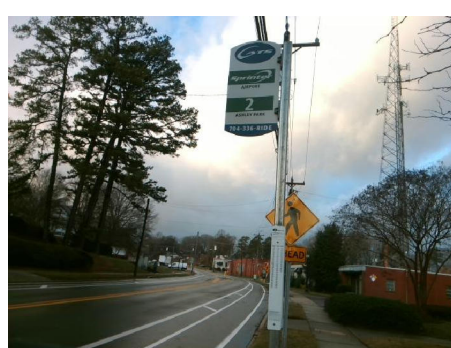
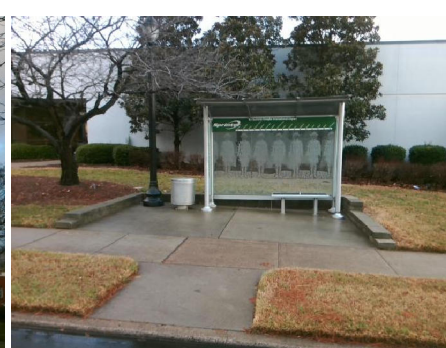
| Compliance | Description | Data |
|---|---|---|
| No | Boarding Area Slope % | 3.5 |
| No | Boarding Area XSlope % | 4.3 |
| No | PAR 2 Exist? | Yes |
| No | PAR 2 XSlope % | 4.2 |
| No | Clear Floor Space | Yes |
| No | Clear Floor Space XSlope % | 3.6 |
| No | Protruding Objects? | Yes |

**Remove & Replace Boarding Area.  
Remove & Replace Sidewalk To  
Boarding Area. Remove & Replace  
Clear Floor Space. Remove or  
Relocate Protruding  
Objects/Obstructions.**
