# Access Compliance Report Public Rights-of-Way (Transit Stops)

| Intersection ID: 10033993 | Main Street: PARK_RD | Cross Street: TRADEWINDS_LN | Location: E |
| ADA ID: 518BDCECF666 | Overall Compliance: No | Severity Score: 100 | |

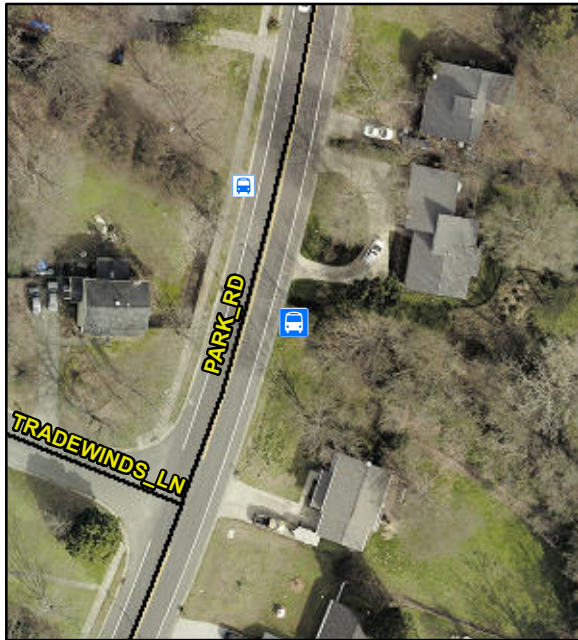
| Compliance | Description | Data |
|---|---|---|
| No | Boarding Area | No |
| No | PAR 1 Exist? | No |
| N/A | Boarding Area Connected to PAR? | No |

**Provide Boarding Area. Provide Sidewalk To Boarding Area.**

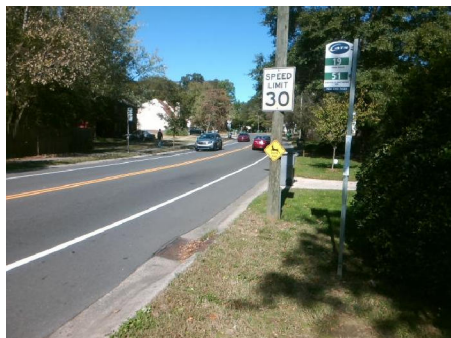
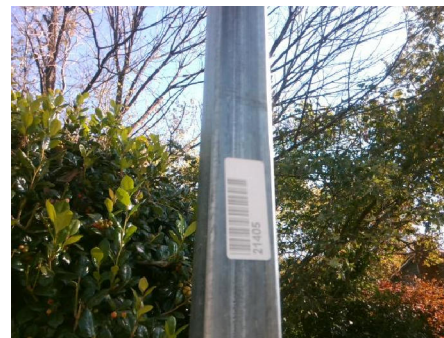
| Compliance | Description | Data |
|---|---|---|
| Yes | Transit Sign? | Yes |
