# Access Compliance Report Public Rights-of-Way (Transit Stops)

| Intersection ID: 21496 | Main Street: SOUTH_BV | Cross Street: STARMOUNT_COVE_LN | Location: SE |
| ADA ID: 53B6BB541131 | Overall Compliance: No | Severity Score: 45 | |

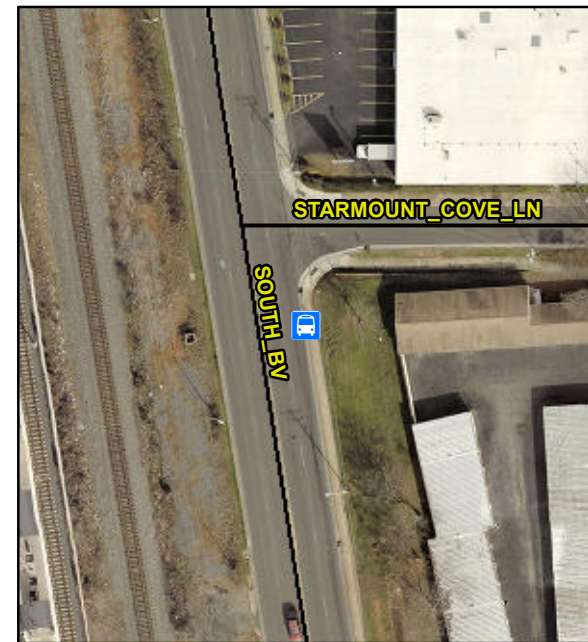
| Compliance | Description | Data |
|---|---|---|
| No | Boarding Area Length (in) | 64.0 |
| No | Boarding Area Slope % | 2.3 |
| No | PAR 1 Exist? | Yes |
| No | PAR 1 XSlope % | 3.0 |
| No | PAR 2 Exist? | Yes |
| No | PAR 2 XSlope % | 2.2 |

**Remove & Replace Boarding Area.  
Remove & Replace Sidewalk To  
Boarding Area.**
