# Access Compliance Report Public Rights-of-Way (Transit Stops)

| Intersection ID: 10031278 | Main Street: MARVIN_RD | Cross Street: N/A | Location: SW |
| ADA ID: 596C31A18EE7 | Overall Compliance: No | Severity Score: 100 | |

CATS Stop Description: **Marvin Rd & Villa Ct**

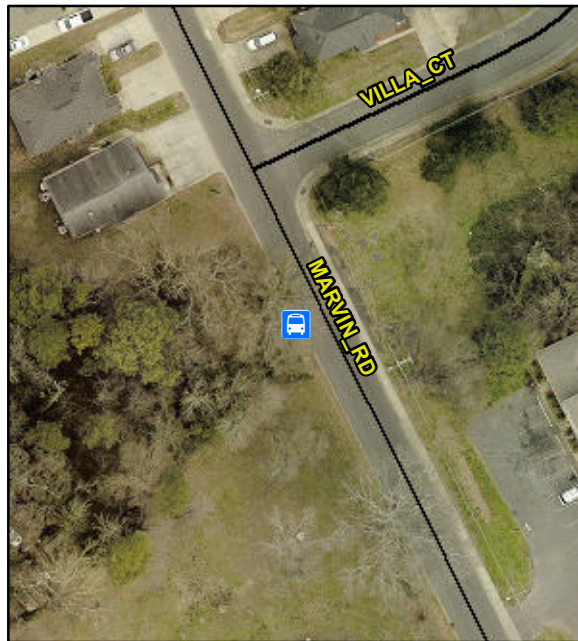
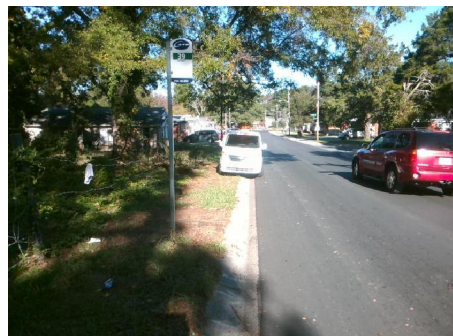
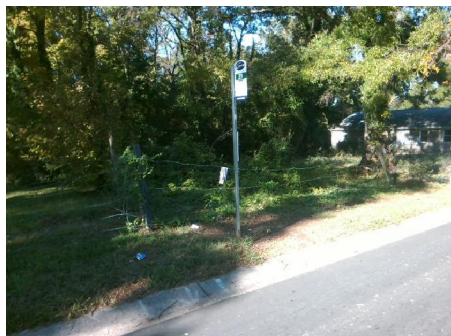
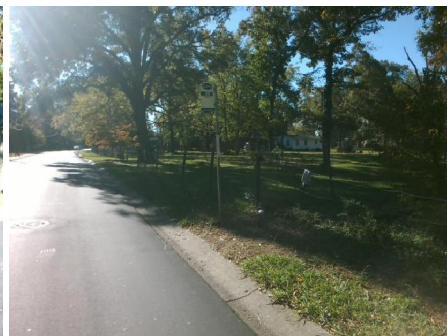
| Compliance | Description | Data |
|---|---|---|
| No | Boarding Area | No |
| No | PAR 1 Exist? | No |
| N/A | Boarding Area Connected to PAR? | No |
| Yes | Transit Sign? | Yes |
| Yes | Transit Sign Height (in) | 95.0 |

**Provide Boarding Area. Provide Sidewalk To Boarding Area.**
