# Access Compliance Report Public Rights-of-Way (Transit Stops)

| Intersection ID: 10030706 | Main Street: LONGLEAF_DR | Cross Street: SOUTH_BV | Location: S |
| ADA ID: 5F409EAC6F7C | Overall Compliance: No | Severity Score: 80 | |

CATS Stop ID: **14420**  
CATS Stop Description: **Longleaf Dr & South Blvd**  
CATS Route ID: **12**  
CATS Route Name: **South Boulevard**

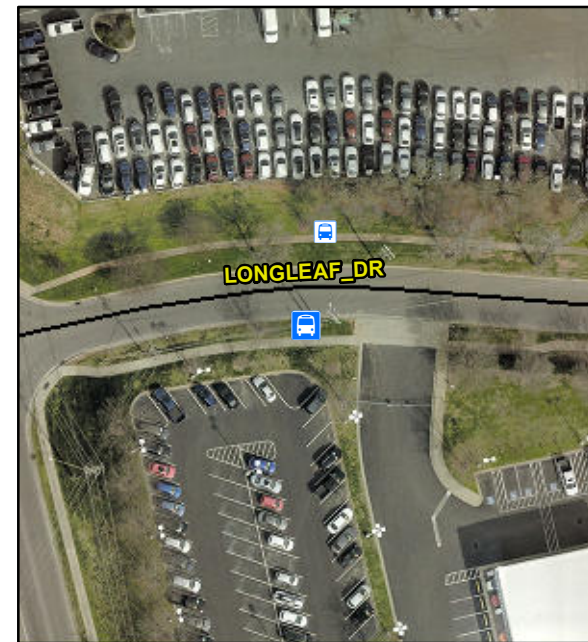
| Compliance | Description | Data |
|---|---|---|
| No | Boarding Area | No |
| No | PAR 1 Exist? | Yes |
| No | PAR 1 Slope % | 3.6 |
| No | Boarding Area Connected to PAR? | No |
| No | Protruding Objects? | Yes |

**Provide Boarding Area. Remove & Replace Sidewalk To Boarding Area. Remove or Relocate Protruding Objects/Obstructions.**
