# Access Compliance Report Public Rights-of-Way (Transit Stops)

| Intersection ID: 10032521 | Main Street: N_CHURCH_ST | Cross Street: N/A | Location: N |
| ADA ID: 60FFA7CCE183 | Overall Compliance: No | Severity Score: 90 | |

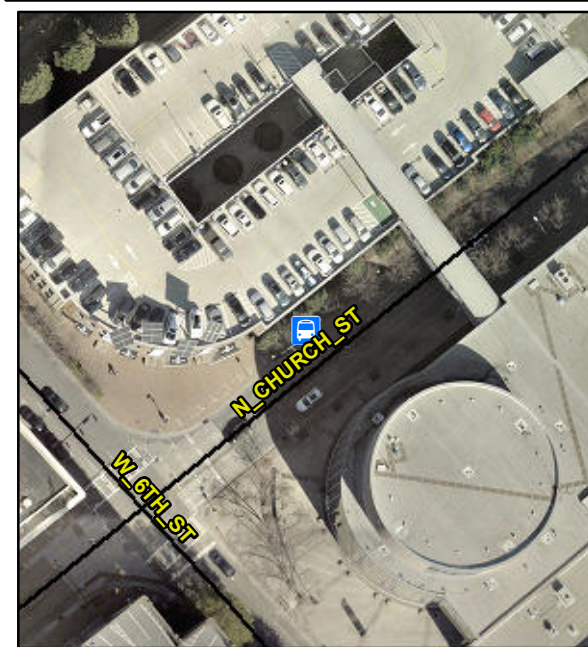
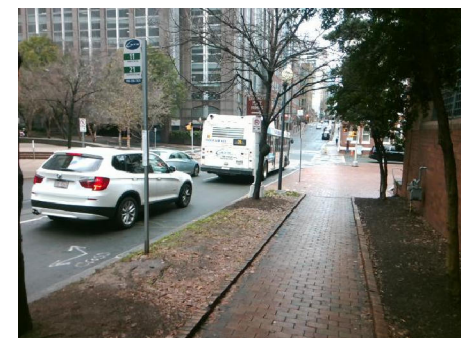
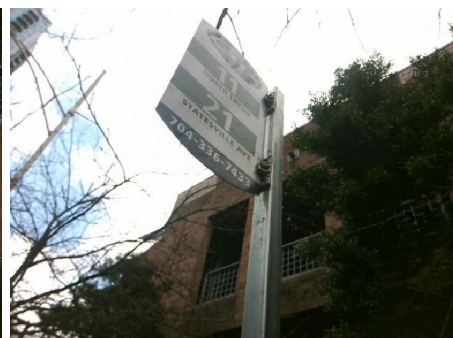
| Compliance | Description | Data |
|---|---|---|
| No | Boarding Area | No |
| No | PAR 2 Exist? | Yes |
| No | PAR 2 Slope % | 7.2 |
| No | Boarding Area Connected to PAR? | No |

**Provide Boarding Area. Remove & Replace Sidewalk To Boarding Area.**
