# Access Compliance Report Public Rights-of-Way (Transit Stops)

| Intersection ID: 10030145 | Main Street: LASALLE_ST | Cross Street: N/A | Location: S |
| ADA ID: 61A36D6D497D | Overall Compliance: No | Severity Score: 40 | |

CATS Stop ID: **39230**  
 CATS Stop Description: **LaSalle St & Madrid St**  
 CATS Route ID: **3**  
 CATS Route Name: **The Plaza**

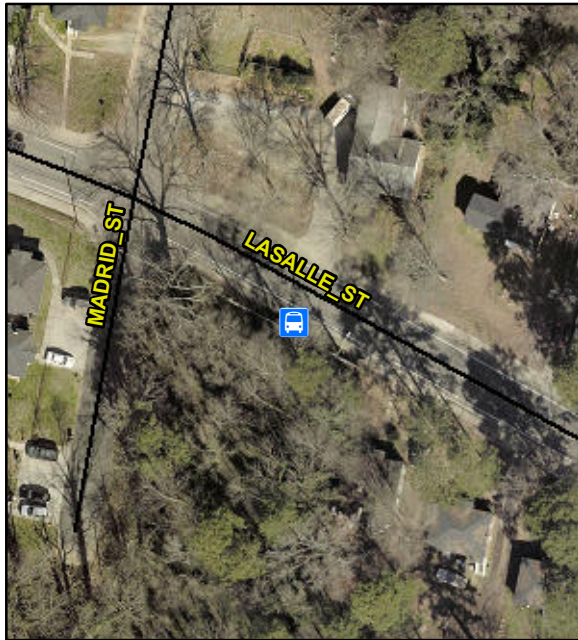
Possible Solutions:

| Compliance | Description | Data |
|---|---|---|
| No | Boarding Area Length (in) | 66.0 |

**Remove & Replace Boarding Area.**
