# Access Compliance Report Public Rights-of-Way (Transit Stops)

| Intersection ID: 10020726 | Main Street: BEATTIES_FORD_RD | Cross Street: N/A | Location: W |
| ADA ID: 655D3A4AF429 | Overall Compliance: No | Severity Score: 15 | |

CATS Stop Description: **Beatties Ford Rd & Rosa Parks PI (Bay C)**

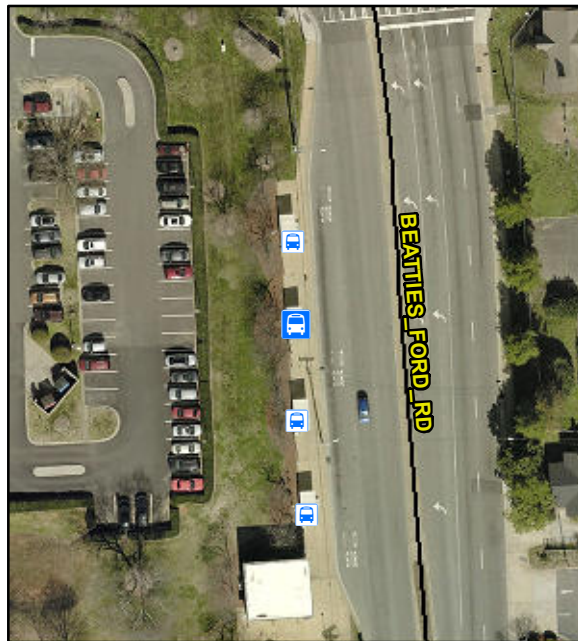
| Compliance | Description | Data |
|---|---|---|
| Yes | Boarding Area | Yes |
| Yes | Boarding Area Width (in) | 60.0 |
| Yes | Boarding Area Length (in) | 96.0 |
| No | Boarding Area Slope % | 2.8 |
| Yes | Boarding Area XSlope % | 1.4 |
| No | PAR 1 Exist? | Yes |
| Yes | PAR 1 Width (in) | 61.0 |
| No | PAR 1 Slope % | 2.1 |
| No | PAR 1 XSlope % | 2.8 |
| No | PAR 2 Exist? | Yes |
| Yes | PAR 2 Width (in) | 61.0 |
| No | PAR 2 Slope % | 2.3 |

**Remove & Replace Boarding Area.  
Remove & Replace Sidewalk To  
Boarding Area. Remove & Replace  
Clear Floor Space. Remove or  
Relocate Protruding  
Objects/Obstructions. Adjust Transit**

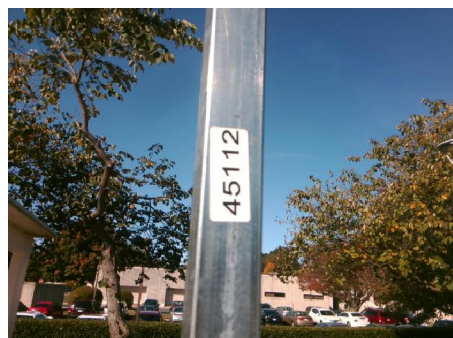
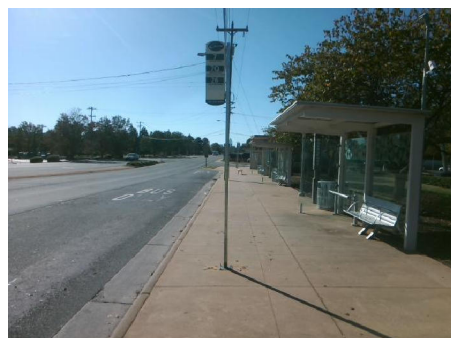
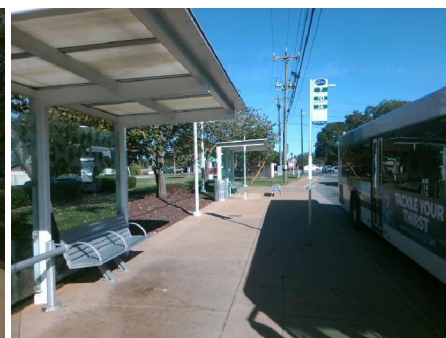
| Compliance | Description | Data |
|---|---|---|
| No | PAR 2 XSlope % | 2.9 |
| No | Clear Floor Space XSlope % | 2.9 |
| No | Transit Sign Height (in) | 60.0 |
| No | Protruding Objects? | Yes |
