# Access Compliance Report Public Rights-of-Way (Transit Stops)

| Intersection ID: 10035417 | Main Street: RANDOLPH_RD | Cross Street: N/A | Location: SW |
| ADA ID: 66D4674C6522 | Overall Compliance: No | Severity Score: 35 | |

CATS Stop Description: **Randolph Rd & Museum Plaza**

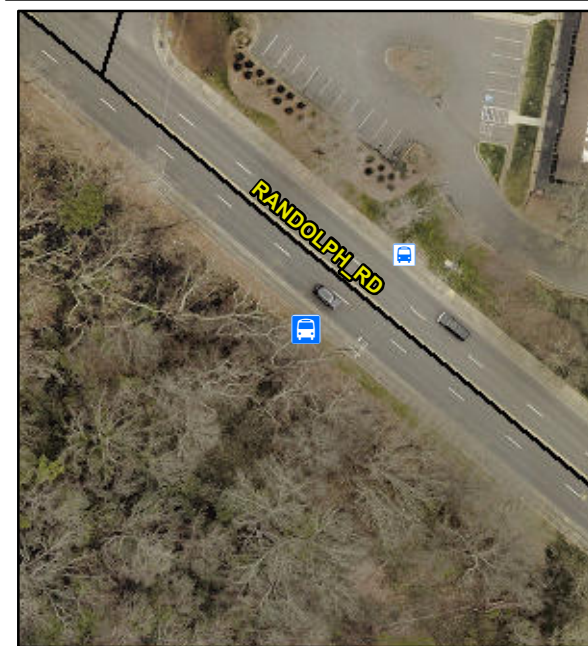
| Compliance | Description | Data |
|---|---|---|
| No | PAR 1 Exist? | Yes |
| No | PAR 1 Slope % | 4.1 |
| No | PAR 2 Exist? | Yes |
| No | PAR 2 XSlope % | 2.8 |
| No | Clear Floor Space | Yes |
| No | Clear Floor Space Length (in) | 35.0 |
| No | Clear Floor Space Slope % | 2.3 |
| No | Clear Floor Space XSlope % | 4.2 |

Possible Solutions:

**Remove & Replace Sidewalk To Boarding Area. Remove & Replace Clear Floor Space.**
