# Access Compliance Report Public Rights-of-Way (Transit Stops)

| Intersection ID: 10016084 | Main Street: CINDY_AV | Cross Street: N/A | Location: S |
| ADA ID: 68681AEB833C | Overall Compliance: No | Severity Score: 100 | |

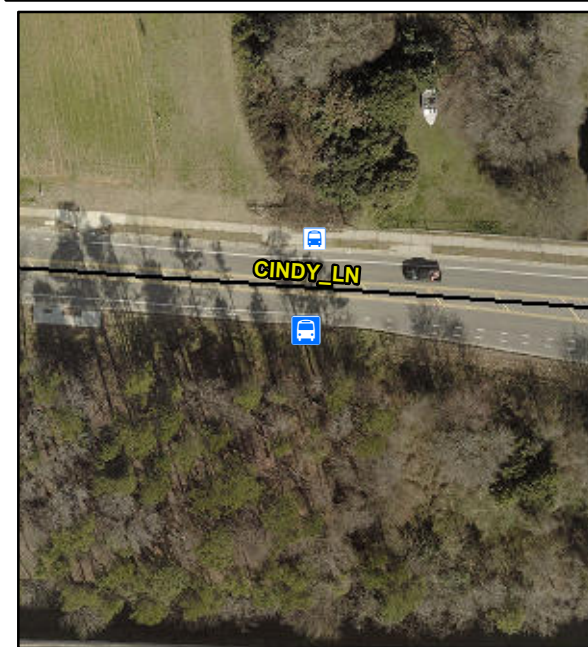
| Compliance | Description | Data |
|---|---|---|
| No | Boarding Area | No |
| No | PAR 1 Exist? | No |
| N/A | Boarding Area Connected to PAR? | No |

**Provide Boarding Area. Provide Sidewalk To Boarding Area.**

**402.2, 810.2, R302, R308.1.1**

Total Cost: \$ **1200.00**
