# Access Compliance Report Public Rights-of-Way (Transit Stops)

| Intersection ID: 10016996 | Main Street: CINDY_LN | Cross Street: N/A | Location: N |
| ADA ID: 68C4BF077578 | Overall Compliance: No | Severity Score: 45 | |

CATS Stop ID: **59791**  
 CATS Stop Description: **Cindy Ln & Juniper Dr**  
 CATS Route ID: **13**  
 CATS Route Name: **Nevin Road**

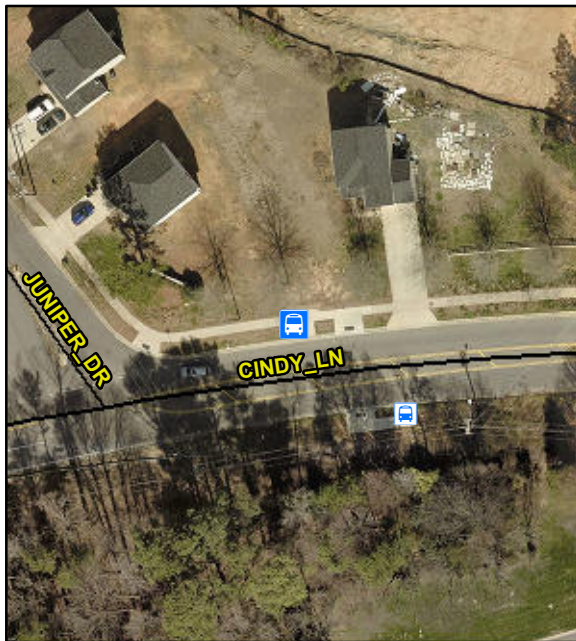
| Compliance | Description | Data |
|---|---|---|
| No | PAR 2 Exist? | Yes |
| No | PAR 2 Slope % | 3.4 |

Possible Solutions:

**Remove & Replace Sidewalk To Boarding Area.**
