# Access Compliance Report Public Rights-of-Way (Transit Stops)

| Intersection ID: 10019893 | Main Street: ARCHDALE_DR | Cross Street: N/A | Location: N |
| ADA ID: 72F4758B6D67 | Overall Compliance: No | Severity Score: 85 | |

CATS Stop ID: **46260**  
 CATS Stop Description: **Archdale Dr & Park Rd**  
 CATS Route ID: **57**  
 CATS Route Name: **Archdale**

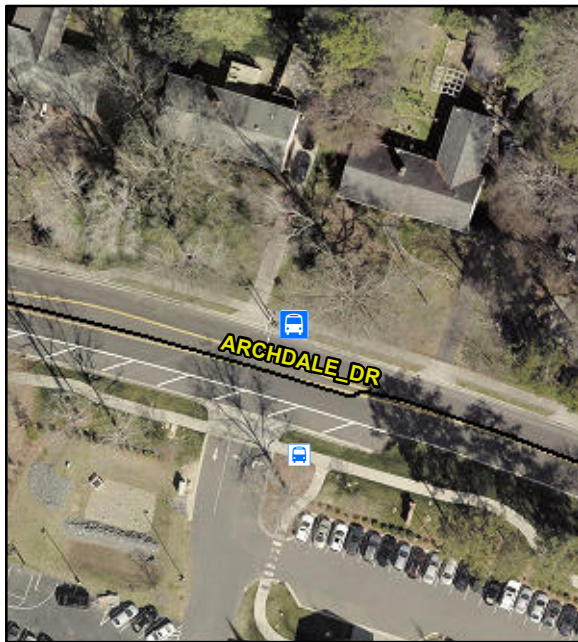
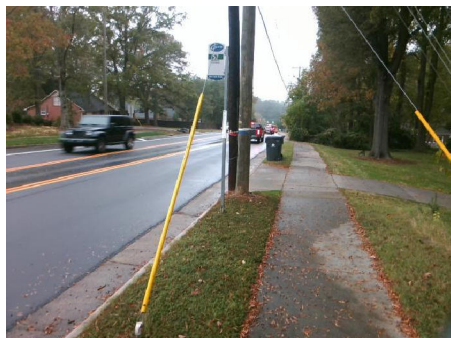
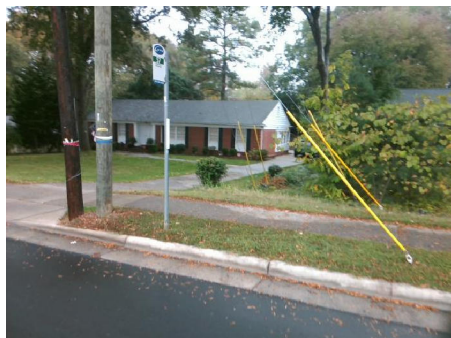
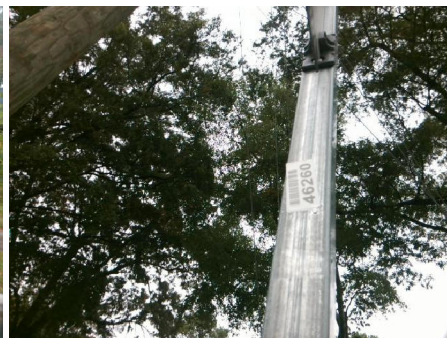
| Compliance | Description | Data |
|---|---|---|
| No | Boarding Area | No |
| No | PAR 2 Exist? | Yes |
| No | PAR 2 Slope % | 2.7 |
| No | Boarding Area Connected to PAR? | No |

**Provide Boarding Area. Remove & Replace Sidewalk To Boarding Area.**
