# Access Compliance Report Public Rights-of-Way (Transit Stops)

| Intersection ID: 10037442 | Main Street: SCOTT_AV | Cross Street: BLYTHE_BV | Location: E |
| ADA ID: 74B94618ACB1 | Overall Compliance: No | Severity Score: 40 | |

CATS Stop Description: **Scott Ave & Blythe Blvd**

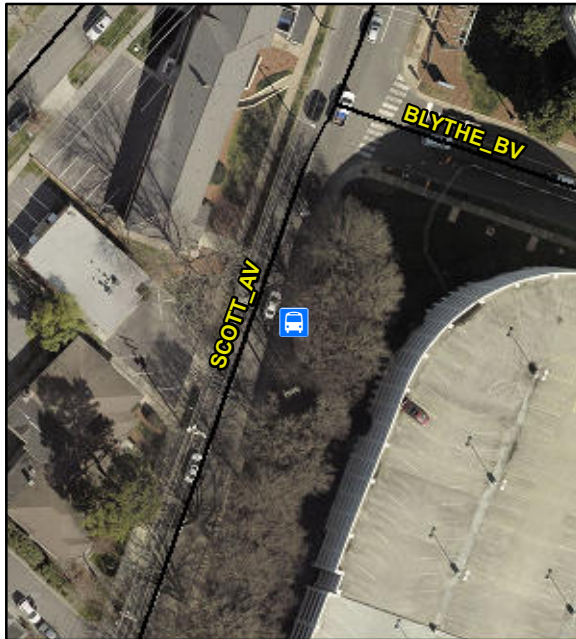
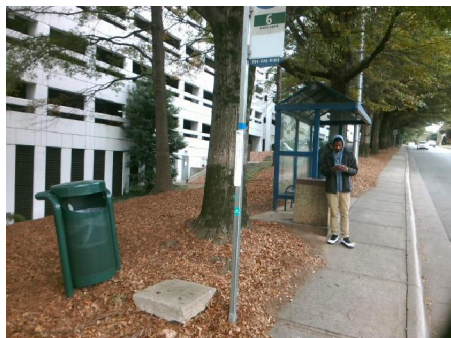
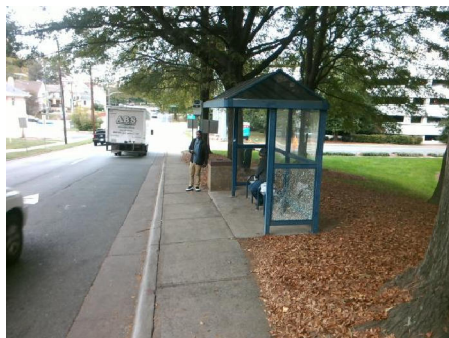
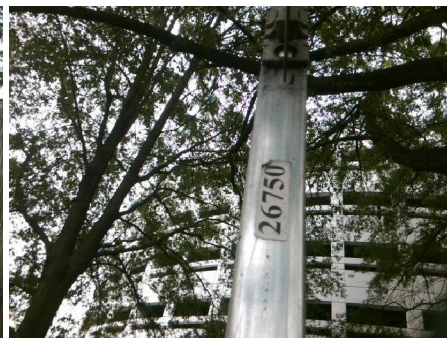
| Compliance | Description | Data |
|---|---|---|
| No | Boarding Area Length (in) | 86.0 |
| No | Boarding Area Slope % | 4.1 |
| No | PAR 1 Exist? | Yes |
| No | PAR 1 XSlope % | 4.1 |
| No | PAR 2 Exist? | Yes |
| No | PAR 2 XSlope % | 4.2 |
| No | Clear Floor Space | Yes |
| No | Clear Floor Space XSlope % | 8.5 |
| No | Protruding Objects? | Yes |

**Remove & Replace Boarding Area.  
Remove & Replace Sidewalk To  
Boarding Area. Remove & Replace  
Clear Floor Space. Remove or  
Relocate Protruding  
Objects/Obstructions.**
