# Access Compliance Report Public Rights-of-Way (Transit Stops)

| Intersection ID: 10036718 | Main Street: S_COLLEGE_ST | Cross Street: E_3RD_ST | Location: S |
| ADA ID: 7598BD01A9BE | Overall Compliance: No | Severity Score: 45 | |

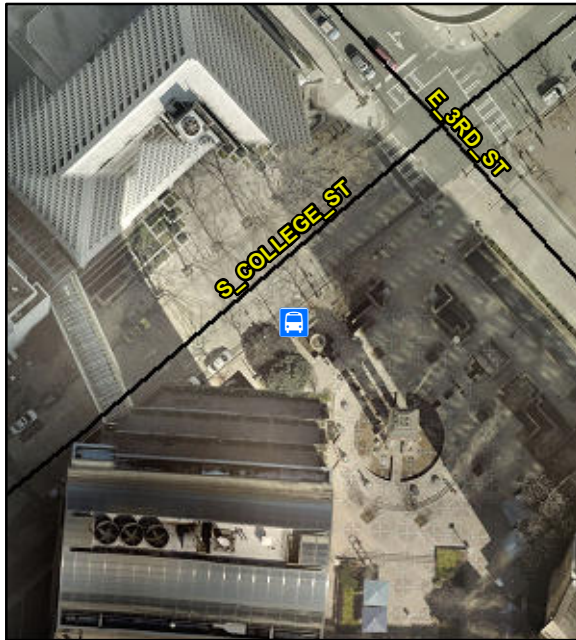
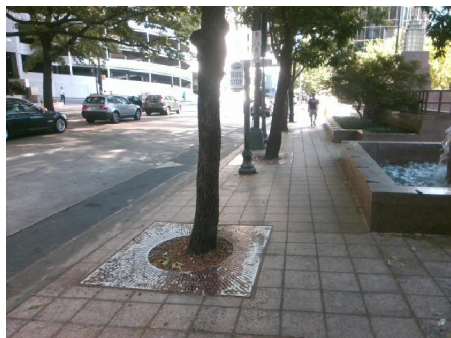
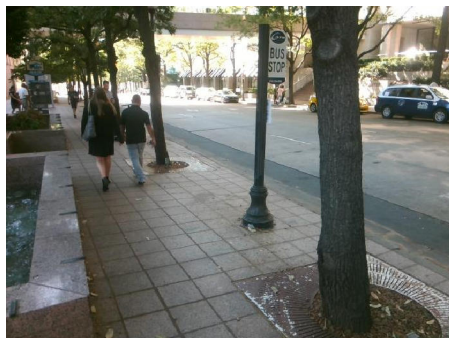
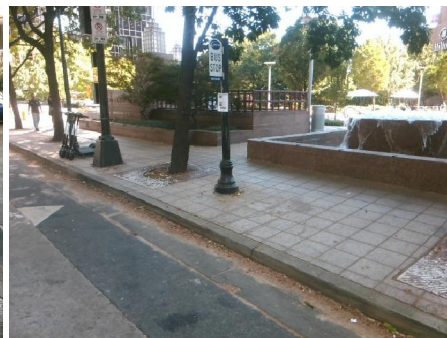
| Compliance | Description | Data |
|---|---|---|
| No | Boarding Area Slope % | 4.0 |
| No | PAR 1 XSlope % | 4.3 |
| No | PAR 2 XSlope % | 4.6 |
| No | Transit Sign Height (in) | 71.5 |

**Remove & Replace Boarding Area.  
Remove & Replace Sidewalk To  
Boarding Area. Adjust Transit Stop  
Sign Height.**
