# Access Compliance Report

## Public Rights-of-Way

### (Transit Stops)

CATS Stop Description: **West Blvd & Romare Bearden Dr**

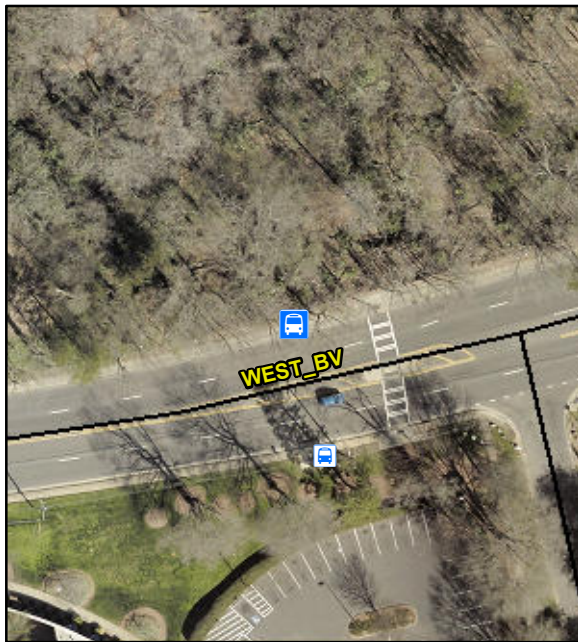
**NO CATS ID LISTED**

| Compliance | Description | Data |
|---|---|---|
| No | Boarding Area XSlope % | 4.7 |
| No | PAR 2 Exist? | Yes |
| No | PAR 2 Slope % | 4.5 |
| No | PAR 2 XSlope % | 2.7 |
| No | Clear Floor Space | Yes |
| No | Clear Floor Space Slope % | 2.6 |
| No | Clear Floor Space XSlope % | 2.3 |

**Remove & Replace Boarding Area.  
Remove & Replace Sidewalk To  
Boarding Area. Remove & Replace  
Clear Floor Space.**
