# Access Compliance Report Public Rights-of-Way (Transit Stops)

| Intersection ID: 10014702 | Main Street: PERIWINKLE_HILL_AV | Cross Street: N/A | Location: E |
| ADA ID: 7B08F6E2566F | Overall Compliance: No | Severity Score: 10 | |

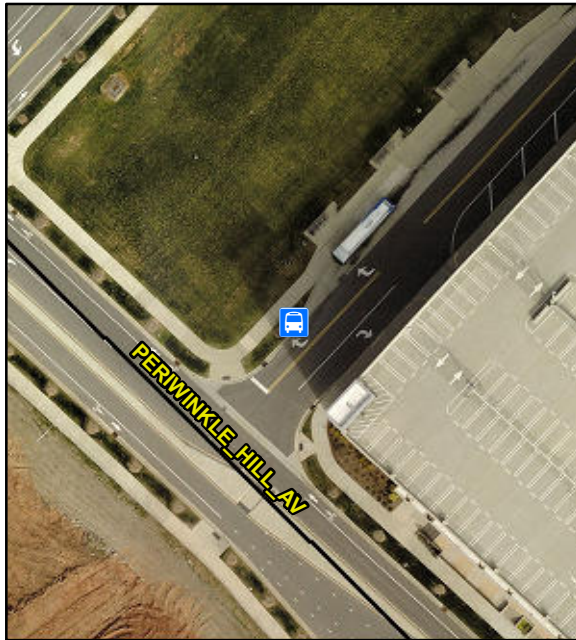
**Transit stop is further NE from point  
outside collection area**

| Compliance | Description | Data |
|---|---|---|
| No | Boarding Area Slope % | 2.2 |
| No | PAR 2 XSlope % | 2.4 |
| No | Protruding Objects? | Yes |

**Remove & Replace Boarding Area.  
Remove & Replace Sidewalk To  
Boarding Area. Remove or Relocate  
Protruding Objects/Obstructions.**
