# Access Compliance Report Public Rights-of-Way (Transit Stops)

| Intersection ID: 10020900 | Main Street: BELLHAVEN_BV | Cross Street: N/A | Location: SW |
| ADA ID: 7D9AC2E97CA8 | Overall Compliance: No | Severity Score: 85 | |

CATS Stop Description: **Bellhaven Blvd & Bellhaven Cir**

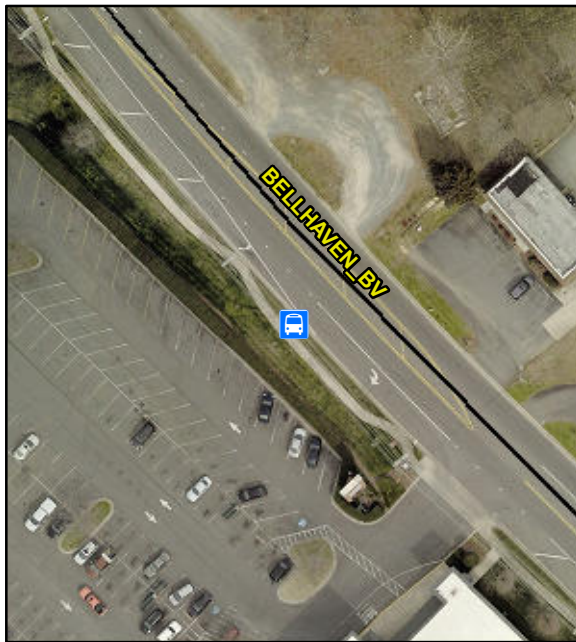
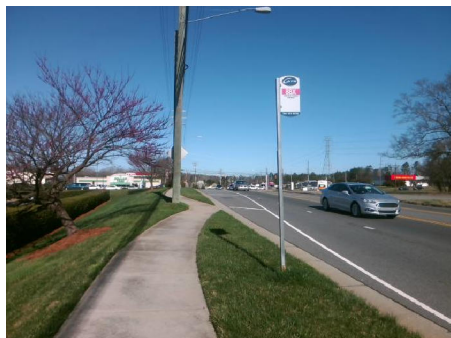
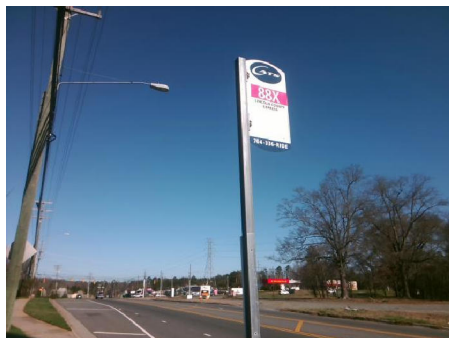
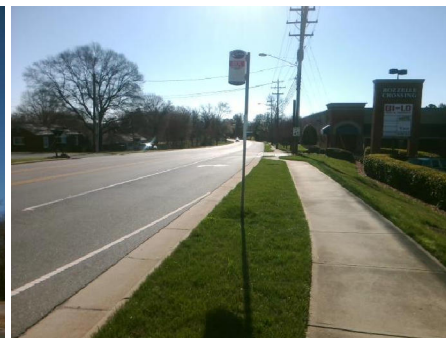
| Compliance | Description | Data |
|---|---|---|
| No | Boarding Area | No |
| No | PAR 1 Exist? | Yes |
| No | PAR 1 Slope % | 3.1 |
| No | PAR 1 XSlope % | 2.8 |
| No | Boarding Area Connected to PAR? | No |

**Provide Boarding Area. Remove & Replace Sidewalk To Boarding Area.**
