# Access Compliance Report Public Rights-of-Way (Transit Stops)

| Intersection ID: 10025286 | Main Street: E_3RD_ST | Cross Street: N/A | Location: S |
| ADA ID: 7EA915A90F06 | Overall Compliance: No | Severity Score: 45 | |

CATS Stop ID: **45825**  
CATS Stop Description: **3rd St & Torrence St**  
CATS Route ID: **14, 15, 61x, 62x**  
CATS Route Name: **Multiple**

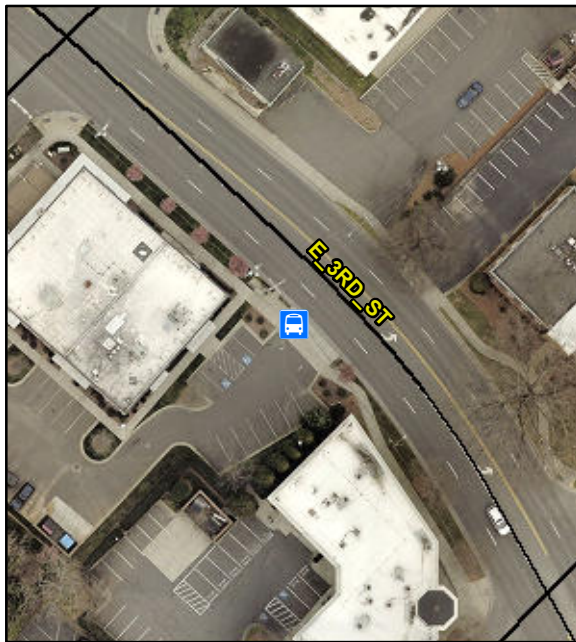
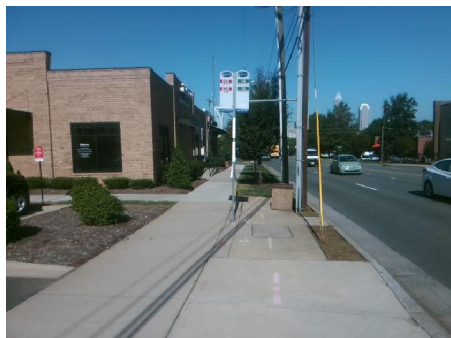
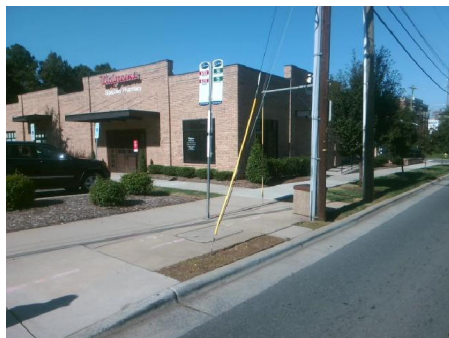
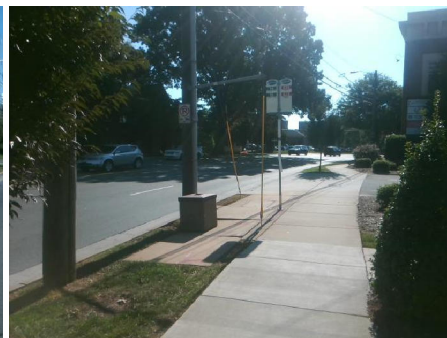
| Compliance | Description | Data |
|---|---|---|
| No | Boarding Area Width (in) | 41.0 |
| No | Boarding Area Slope % | 2.8 |
| No | Boarding Area XSlope % | 3.1 |
| No | PAR 1 XSlope % | 3.9 |
| No | PAR 2 XSlope % | 2.9 |
| No | Protruding Objects? | Yes |

**Remove & Replace Boarding Area.  
Remove & Replace Sidewalk To  
Boarding Area. Remove or Relocate  
Protruding Objects/Obstructions.**
