# Access Compliance Report Public Rights-of-Way (Transit Stops)

| Intersection ID: 10042554 | Main Street: ORCHID_BRIDGE_RD | Cross Street: N/A | Location: S |
| ADA ID: 819B86A490A2 | Overall Compliance: No | Severity Score: 35 | |

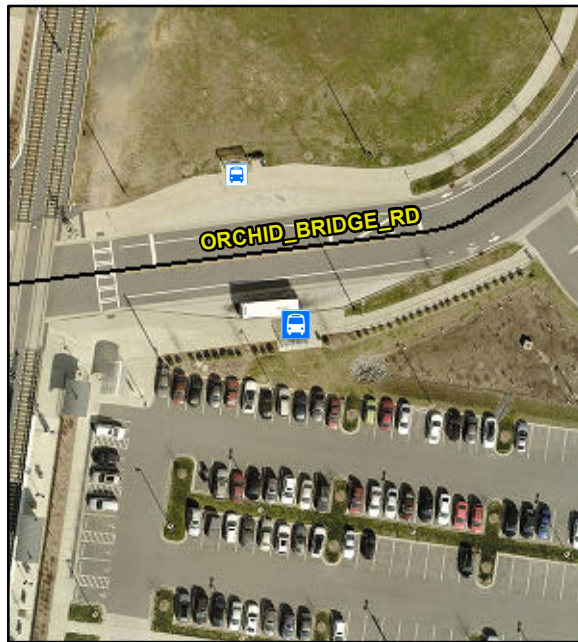
**BACK WALL GLASS BROKEN**

| Compliance | Description | Data |
|---|---|---|
| No | Boarding Area Slope % | 2.2 |
| No | PAR 1 Exist? | Yes |
| No | PAR 1 XSlope % | 2.1 |
| No | PAR 2 Exist? | Yes |
| No | PAR 2 Slope % | 4.4 |

**Remove & Replace Boarding Area.  
Remove & Replace Sidewalk To  
Boarding Area. Remove & Replace  
Clear Floor Space.**

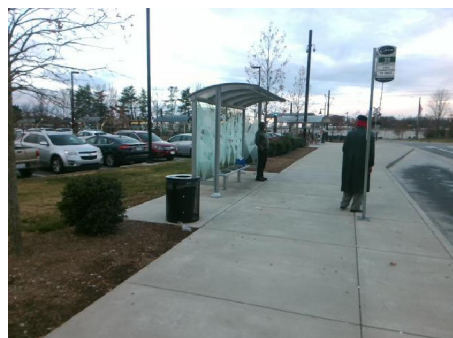
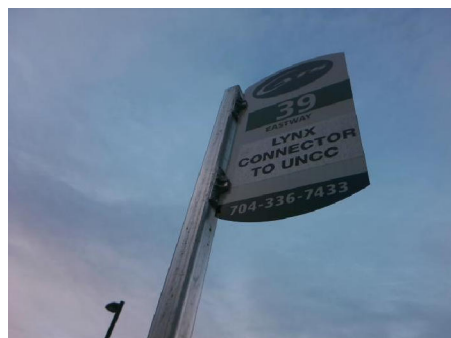
| Compliance | Description | Data |
|---|---|---|
| No | Clear Floor Space Slope % | 2.4 |
| No | Clear Floor Space XSlope % | 4.6 |
