# Access Compliance Report

## Public Rights-of-Way

### (Transit Stops)

| Intersection ID: 10012087 | Main Street: CINDY_LN | Cross Street: N/A | Location: N |

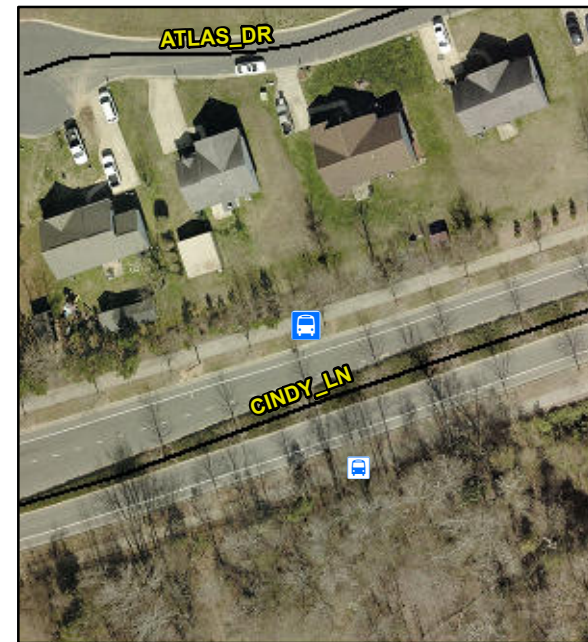
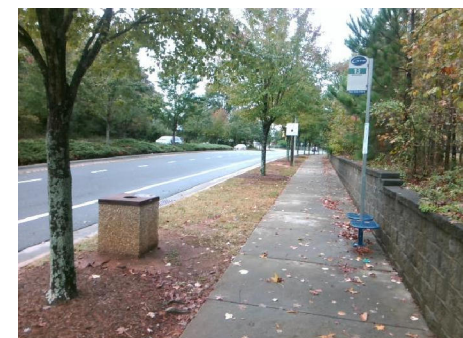
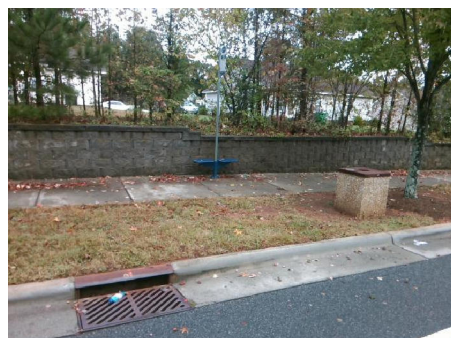
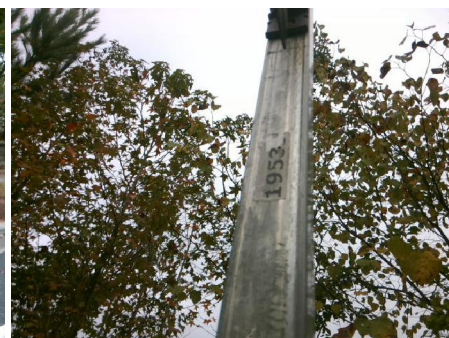
| Compliance | Description | Data |
|---|---|---|
| No | Boarding Area | No |
| No | PAR 1 Exist? | Yes |
| No | PAR 1 Slope % | 2.9 |
| No | PAR 2 Exist? | Yes |
| No | PAR 2 Slope % | 3.2 |
| No | PAR 2 XSlope % | 2.9 |
| No | Boarding Area Connected to PAR? | No |
| No | Clear Floor Space | No |
| No | Protruding Objects? | Yes |

**Provide Boarding Area. Remove & Replace Sidewalk To Boarding Area. Provide Clear Floor Space. Remove or Relocate Protruding Objects/Obstructions.**
