# Access Compliance Report Public Rights-of-Way (Transit Stops)

| Intersection ID: 10012087 | Main Street: CINDY_LN | Cross Street: N/A | Location: S |
| ADA ID: 857030D7AE4D | Overall Compliance: No | Severity Score: 85 | |

CATS Stop ID: **19536**  
 CATS Stop Description: **Cindy Ln & Statesville Rd**  
 CATS Route ID: **13**  
 CATS Route Name: **Nevin Road**

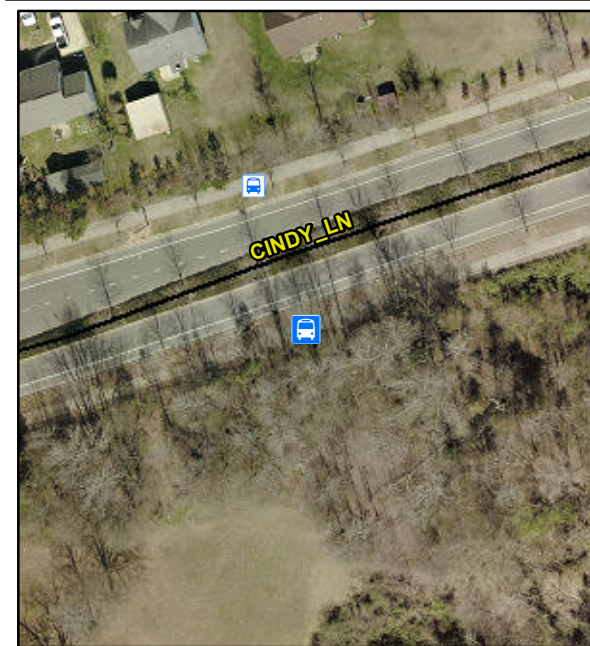
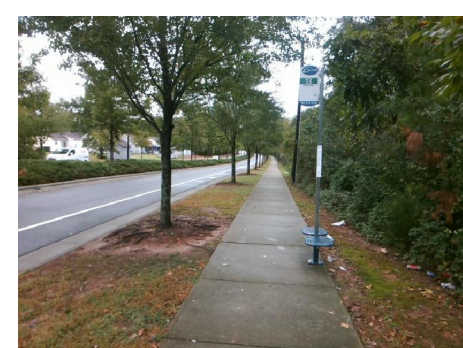
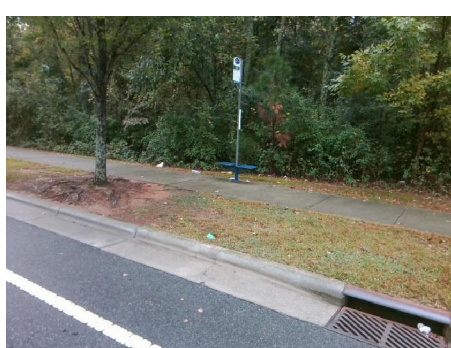
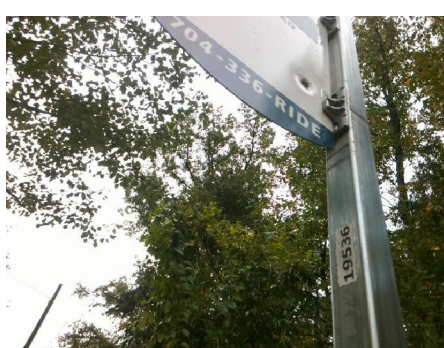
| Compliance | Description | Data |
|---|---|---|
| No | Boarding Area | No |
| No | PAR 2 Exist? | Yes |
| No | PAR 2 Slope % | 3.5 |
| No | Boarding Area Connected to PAR? | No |
| No | Clear Floor Space | No |

**Provide Boarding Area. Remove & Replace Sidewalk To Boarding Area. Provide Clear Floor Space.**
