# Access Compliance Report Public Rights-of-Way (Transit Stops)

| Intersection ID: 10041333 | Main Street: WEST_BV | Cross Street: ROMARE_BEARDEN_DR | Location: S |
| ADA ID: 86261AFE8381 | Overall Compliance: No | Severity Score: 15 | |

CATS Stop Description: **West Blvd & Romare Bearden Dr**

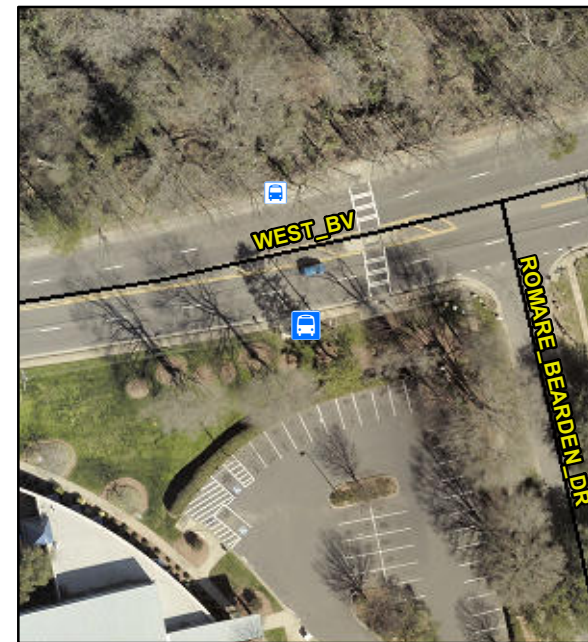
| Compliance | Description | Data |
|---|---|---|
| No | Boarding Area XSlope % | 2.9 |
| No | PAR 1 Slope % | 3.3 |
| No | PAR 2 XSlope % | 2.1 |
| No | Clear Floor Space XSlope % | 2.8 |
| No | Protruding Objects? | Yes |

**Remove & Replace Boarding Area.  
Remove & Replace Sidewalk To  
Boarding Area. Remove & Replace  
Clear Floor Space. Remove or  
Relocate Protruding  
Objects/Obstructions.**
