# Access Compliance Report

## Public Rights-of-Way

### (Transit Stops)

| Intersection ID: 10032545 | Main Street: N_DAVIDSON_ST | Cross Street: E_5TH_ST | Location: E |

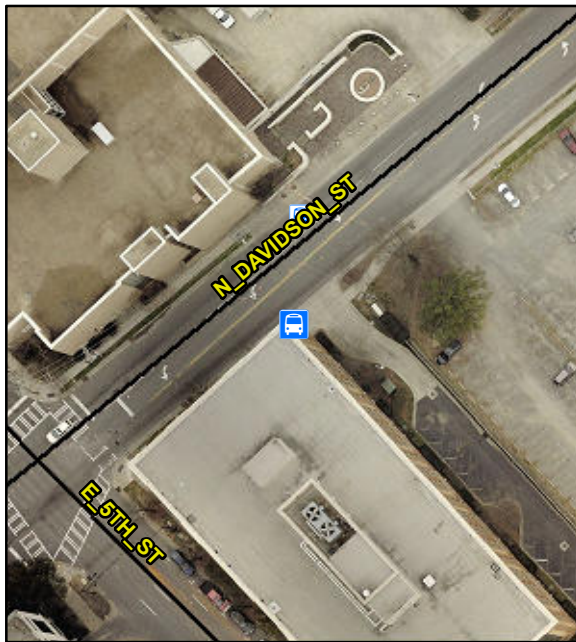
| Compliance | Description | Data |
|---|---|---|
| No | Boarding Area Slope % | 3.9 |
| No | Clear Floor Space | No |
| No | Protruding Objects? | Yes |

**Remove & Replace Boarding Area.  
Provide Clear Floor Space. Remove  
or Relocate Protruding  
Objects/Obstructions.**

**810.2.4, 810.3, R308.1.1.2, R404.1**
