# Access Compliance Report Public Rights-of-Way (Transit Stops)

| Intersection ID: 10015376 | Main Street: THE_PLAZA | Cross Street: N/A | Location: E |
| ADA ID: 8A357F6D5191 | Overall Compliance: No | Severity Score: 40 | |

CATS Stop ID: **31440**  
CATS Stop Description: **The Plaza & Dade St**  
CATS Route ID: **3, 4**  
CATS Route Name: **Multiple**

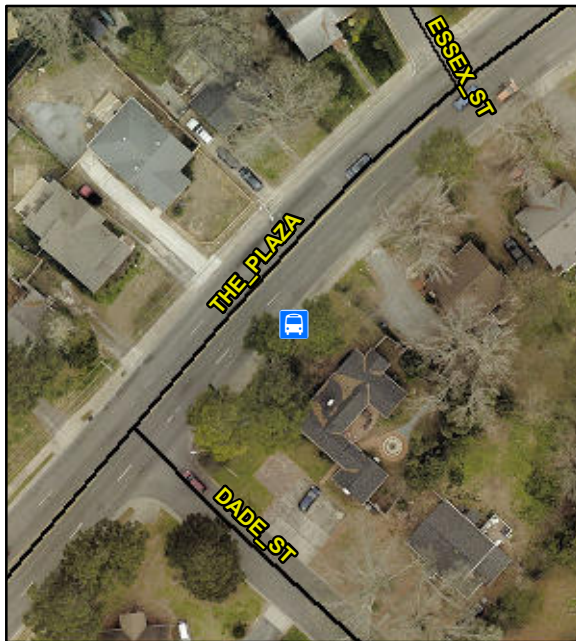
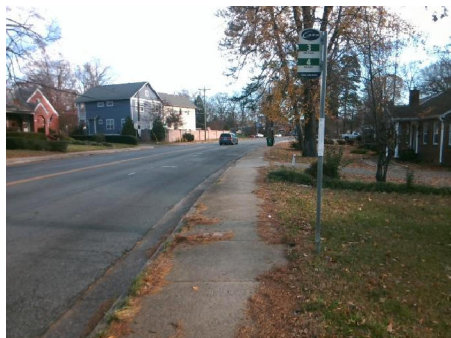
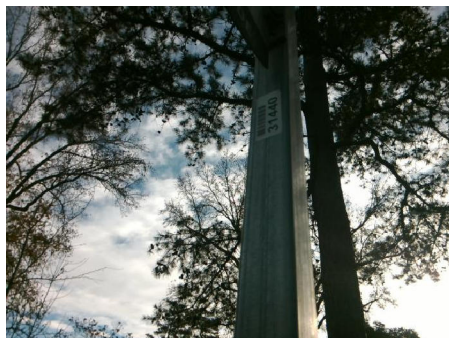
| Compliance | Description | Data |
|---|---|---|
| No | Boarding Area Length (in) | 78.0 |
| No | PAR 2 Exist? | Yes |
| No | PAR 2 XSlope % | 5.1 |

**Remove & Replace Boarding Area.  
Remove & Replace Sidewalk To  
Boarding Area.**
